SERVICE BULLETIN

RS19-004

September 12, 2019

DTC B00A0-00 STORED

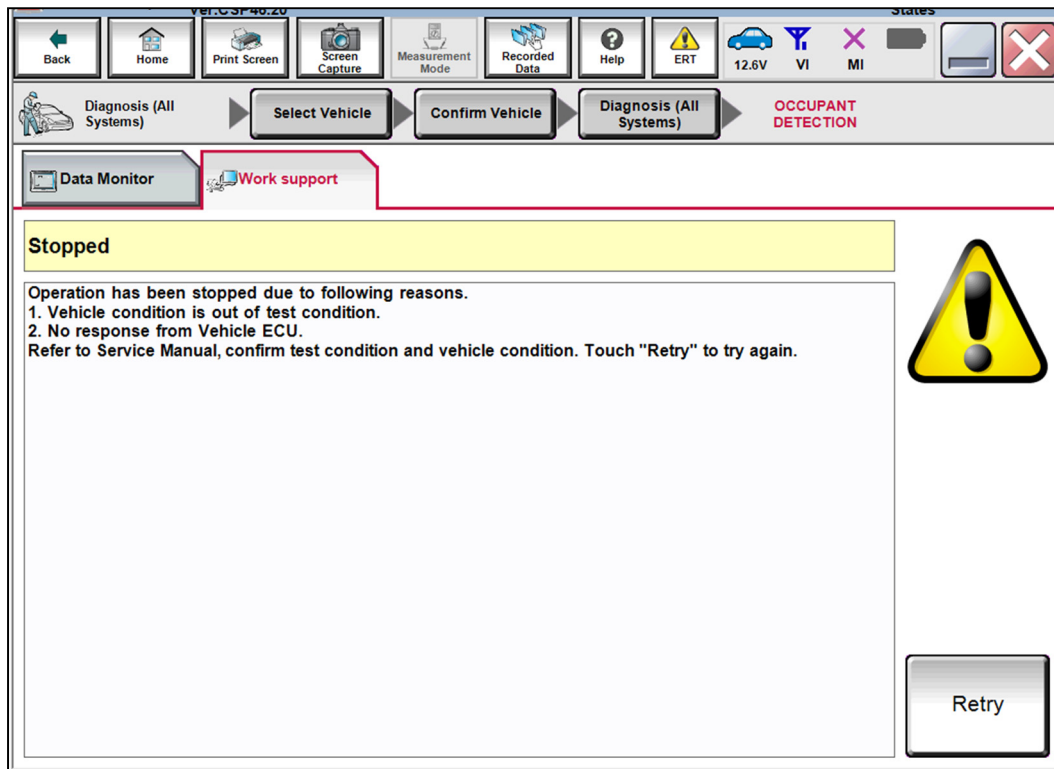
Figure 1

DTC B00A0-00 (OCCUPANT DETECTION SENSOR UNIT) is stored

OCS zero point reset cannot be performed (continued on the next page)

The following screen displays:

1. Check the Occupant Classification System (OCS) control unit using the ODS Analysis tool software.
 - Refer to **SERVICE PROCEDURE** on page 5.

HINT: "OCS" may also be referred to as "ODS".
2. Perform "75-zero RESET".

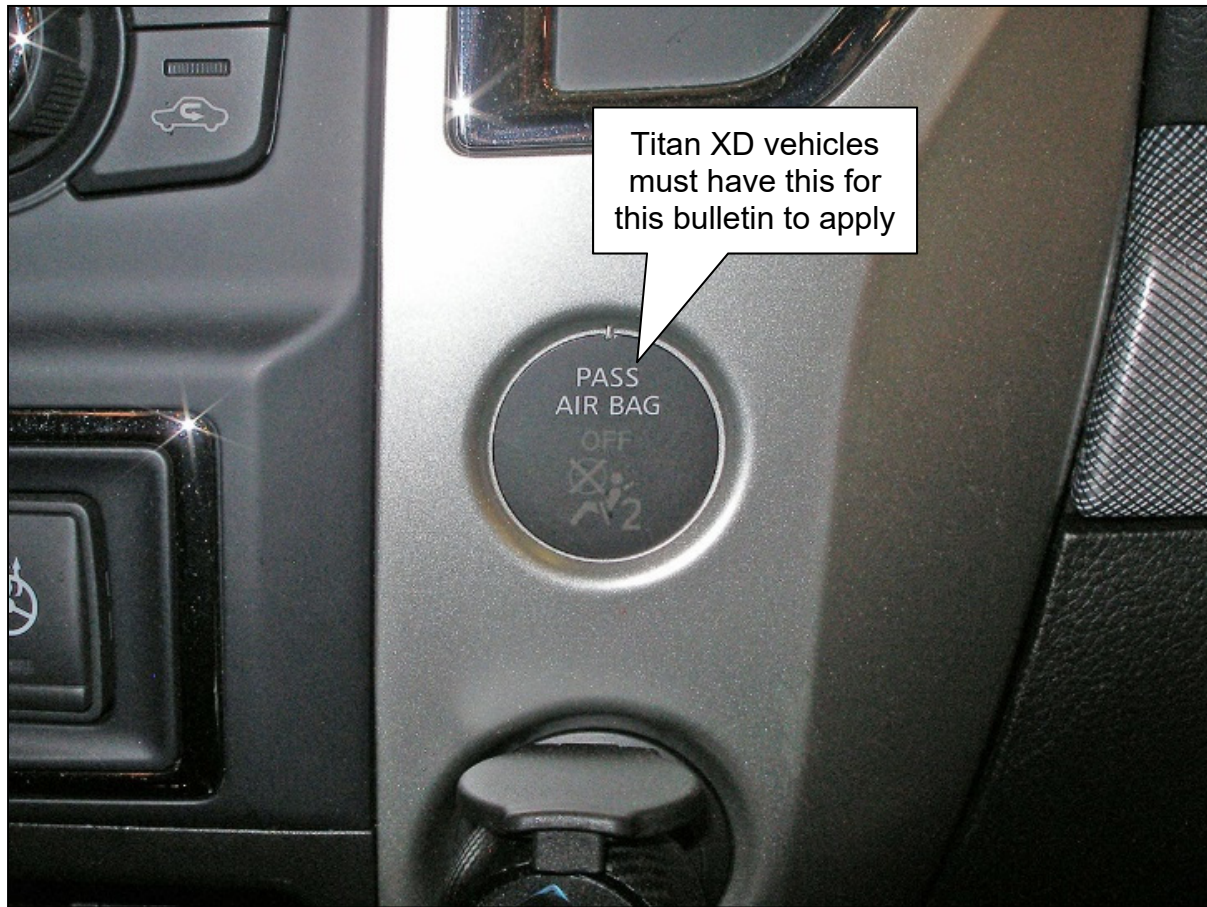
Figure 3

- Titan vehicles: This bulletin applies to ALL Titan vehicles.
- Titan XD vehicles: This bulletin does NOT apply to all Titan XD vehicles. This bulletin applies to Titan XD vehicles equipped with OCS, as indicated by the presence of a front passenger air bag status light (see Figure 3).
