## SERVICE BULLETIN

EL19-023b

### SOFTWARE UPDATES FOR INFOTAINMENT ISSUES

**APPLIED VEHICLES:** 2019 Altima (L34) 2019 Rogue Sport (J11)  
2018-2019 Kicks (P15) 2019 Sentra (B17)  
2019 Maxima (A36) 2019 Titan (A61)  
2019 Murano (Z52) 2019 Titan XD (A61)  
2018-2019 Rogue (T32) 2019 Versa Note (E12)  
2018-2019 Rogue Hybrid (T32)

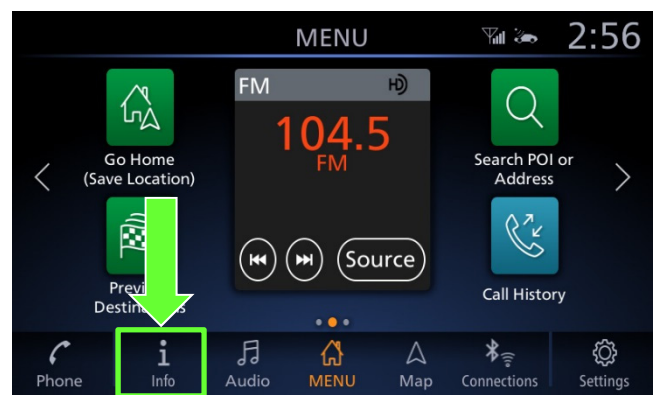
Figure 3

2. Select the Info Icon.
  - If the Info icon does not appear as show in Figure 3, this bulletin does not apply.

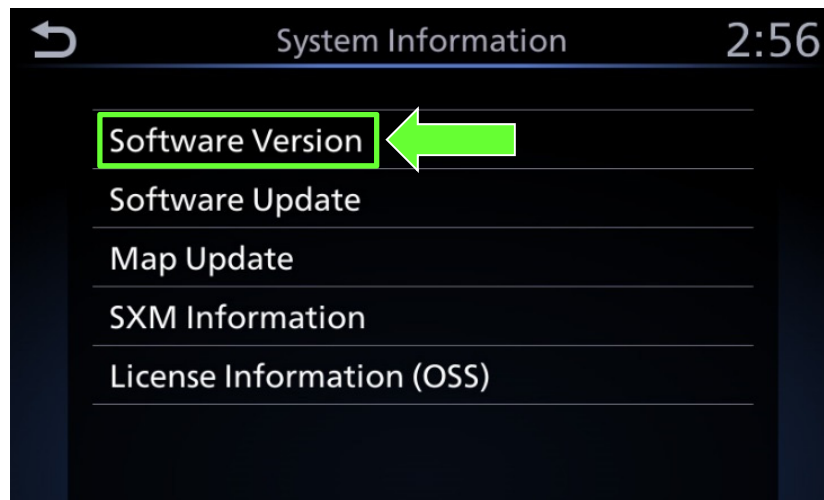
Figure 5

- If the Software version is NOT **0810 or higher**, select the back button and continue to step 5 on the next page.
- If the Software version is **0810 or higher**, select the back button, this bulletin does not apply.

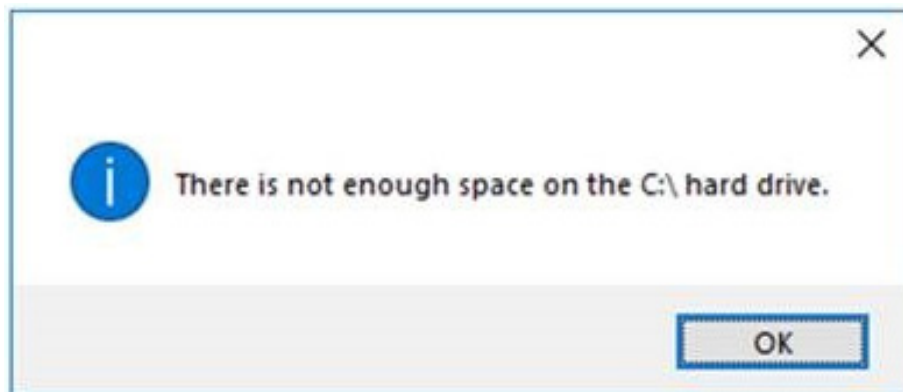
Figure 9

- The update is estimated to take **4 hours** to download to the USB drive.
- If while attempting to download the software to the ASIST Station, you receive the message show in Figure 9:
  - a. First attempt to clear space on the ASIST Station hard drive.
  - b. If space on the hard drive cannot be cleared, email Bosch at **nissan.dealers@us.bosch.com** for additional options.

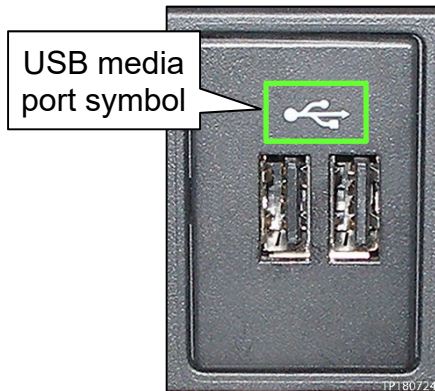
Figure 12

**NOTICE** Do not insert the USB drive into a charging port. If used, the update software and/or USB drive may become damaged. Only insert the USB drive in a USB media port.

16. Insert the USB drive with infotainment update software into the vehicle's USB media port (see Figure 12).
