# SERVICE BULLETIN

AN20-020E

NTB20-046E

## VOLUME KNOB DOES NOT FUNCTION PROPERLY

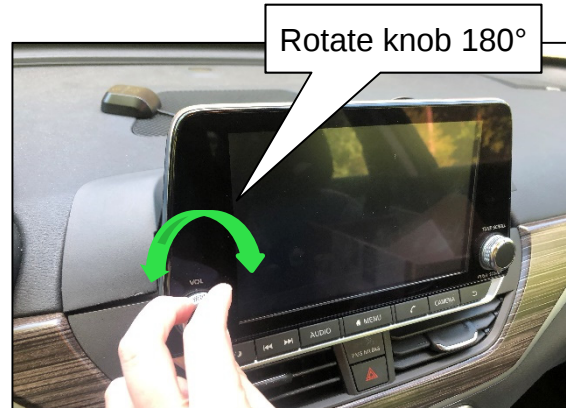
Figure 2  
(Altima shown, other vehicles are similar)

The customer states the speaker volume does not change or changes erratically when rotating the volume knob.

**NOTE:** To ensure a successful repair, steps 2, 3, and 4 **MUST** be performed to remove contaminate build-up on the full 360° radius of the electrical components internal to the volume knob.

1. Turn the audio and the ignition OFF.
2. Rotate the volume knob clockwise and counterclockwise approximately 180° as rapidly as possible for 30 seconds (Figure 2).
3. Rotate the volume knob 180° from its current position to remove the contaminate from the opposite side of the electrical component internal to the volume knob.
4. Rotate the volume knob clockwise and counterclockwise as rapidly as possible for another 30 seconds.
