## SERVICE BULLETIN

EL20-036

NTB20-080

### SOFTWARE UPDATE FOR INFOTAINMENT ISSUES

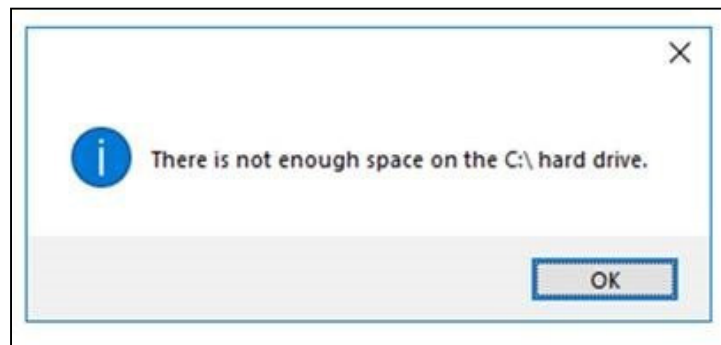
Figure 9

- The update-software is estimated to take **4 hours** to download to the USB drive.
- If, while attempting to download the software to the ASIST Station, you receive the message shown in Figure 9:
  - a. First, attempt to clear space on the ASIST Station hard drive.
  - b. If space on the hard drive cannot be cleared, email Bosch at **nissan.dealers@us.bosch.com** for additional options.

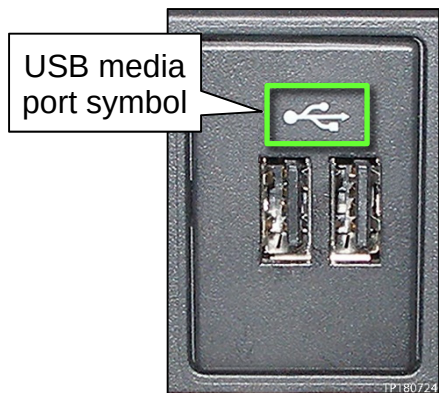
Figure 12

**NOTICE** Do not insert the USB drive into a charging port. If used, the update-software and/or USB drive may become damaged. Only insert the USB drive in a USB media port.

16. Insert the USB drive with the infotainment update-software into the vehicle's USB media port (see Figure 12).
