# SERVICE BULLETIN

AN21-017

NTB21-067

## HIGH FREQUENCY NOISE WITH AUDIO SYSTEM DISPLAY ON

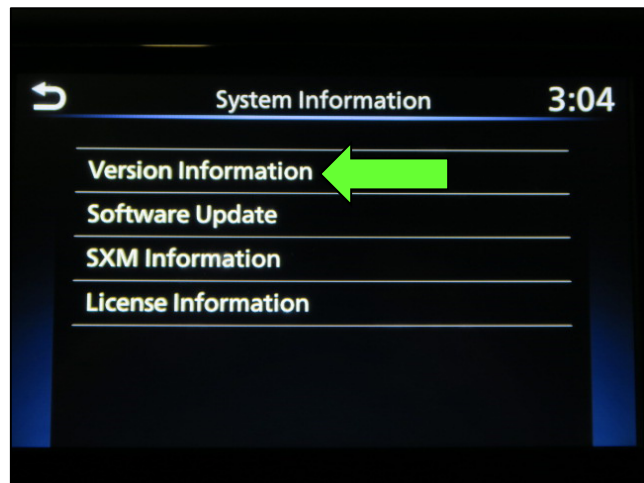
Figure 5

5. Verify the Software Version is **321** or **420**.
- If the software version is 321 or 420, proceed to step 6 on page 5.
  - If the software version is not 321 or 420, the service procedure is complete. Proceed to **CLAIMS INFORMATION** on the last page of this bulletin.

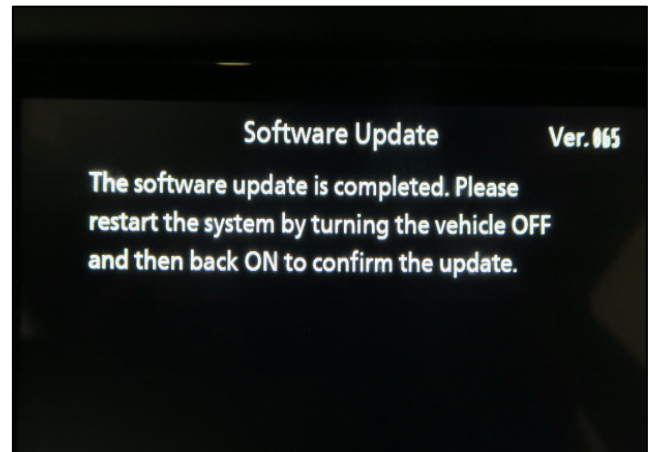
Do not remove the USB drive until the screen in Figure 15 is displayed. If removed prior to this screen being displayed, the Audio Control Unit may be damaged.

20. When the message shown in Figure 15 is displayed, remove the USB drive from the USB media port.
