TECHNICAL SERVICE BULLETIN

AN21-022

CLOCK INACCURATE AND/OR FREEZES

APPLIED VEHICLES: 2020 Kicks (P15) – SR and SV
2020-2021 NV200 (M20)
2020-2021 Versa (N18) – SR and SV

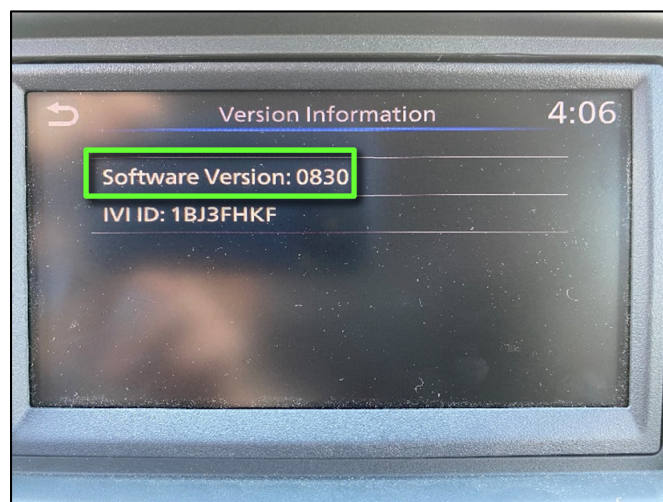
Figure 7

- If the Software Version is NOT **0830**, select the back button and continue to step 6 on the next page.
- If the Software Version is **0830**, select the back button, this bulletin **does not apply**.

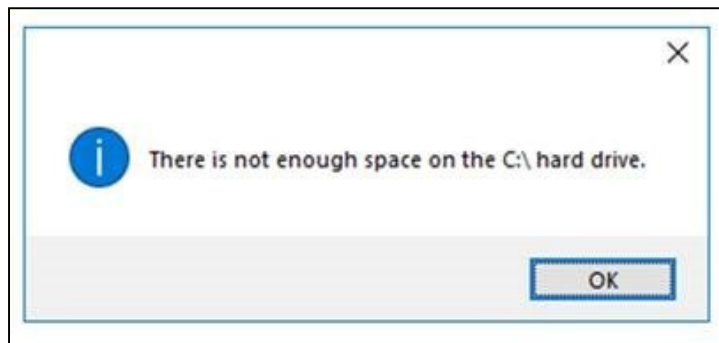
Figure 10

- The update-software is estimated to take **4 hours** to download to the USB drive.
- If, while attempting to download the software to the CONSULT PC, you receive the message shown in Figure 10:
 - Attempt to clear space on the CONSULT PC hard drive.

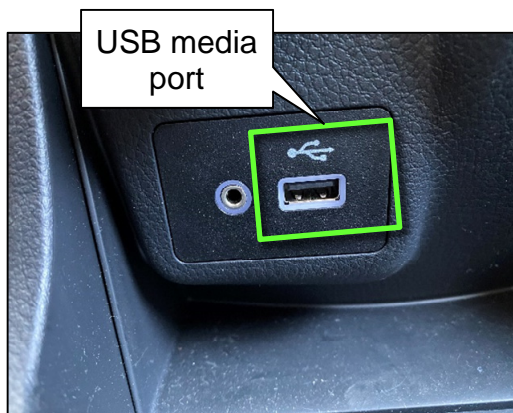
Figure 13

17. Insert the USB drive with the infotainment update-software into the vehicle's USB media port (Figure 13).

Do not insert the USB drive into a charging port. If used, the update-software and/or USB drive may become damaged. Only insert the USB drive in a USB media port.

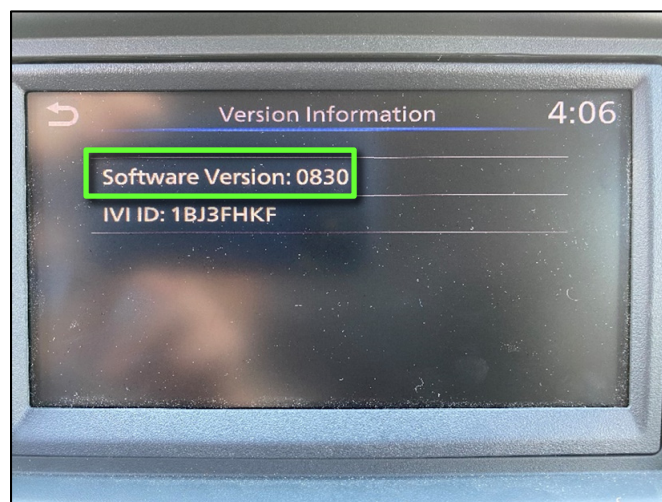
Figure 26

- If the Software Version is NOT **0830**, return to step 6 on page 5 and repeat the reprogramming process.
- If the Software Version is **0830**, proceed to **CLAIMS INFORMATION** on the last page.
