# SERVICE BULLETIN

AN15-005D

## NISSANCONNECT NAVIGATION SYSTEM SOFTWARE UPDATE

| <b>APPLIED SYSTEM:</b> | Vehicles equipped with Navigation | |

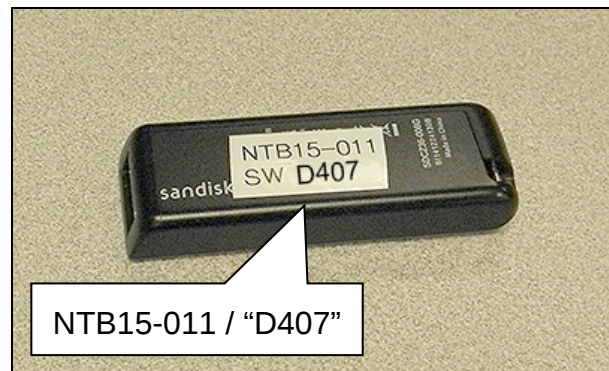
- Each dealer has been mailed one USB drive (Figure 1) free of charge, from Bosch. Please discard any USB drives with the previous software version.

- **If the USB drive shown in Figure 1 cannot be located/used**, download the update-software from ASIST onto a USB drive.

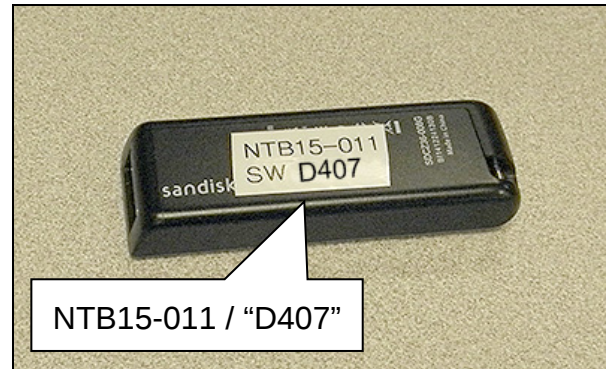
**NOTE:** If the USB drive shown in Figure 5 is available to use for the reprogramming procedure, skip to **Update the Navigation System** on page 8.

- Special tool USB drive J-52727-1 is the only USB drive approved for use with this procedure if the original USB drive (Figure 5) is not available.
- The update-software is estimated to take 1-2 hours to download to the USB drive.
- The update-software must be the only file on the USB drive.

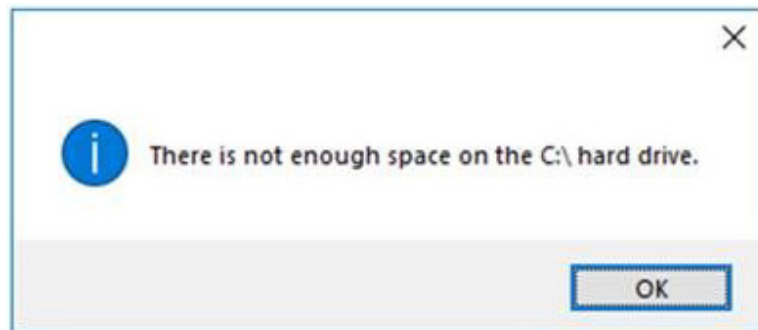
Figure 8

- The update-software is estimated to take 1-2 hours to download to the USB drive.
- If, while attempting to download the software, you receive the message shown in Figure 8:
  - a. First, attempt to clear space on the CONSULT PC hard drive.
  - b. If space on the hard drive cannot be cleared, email Bosch at **nissan.dealers@us.bosch.com** for additional options.

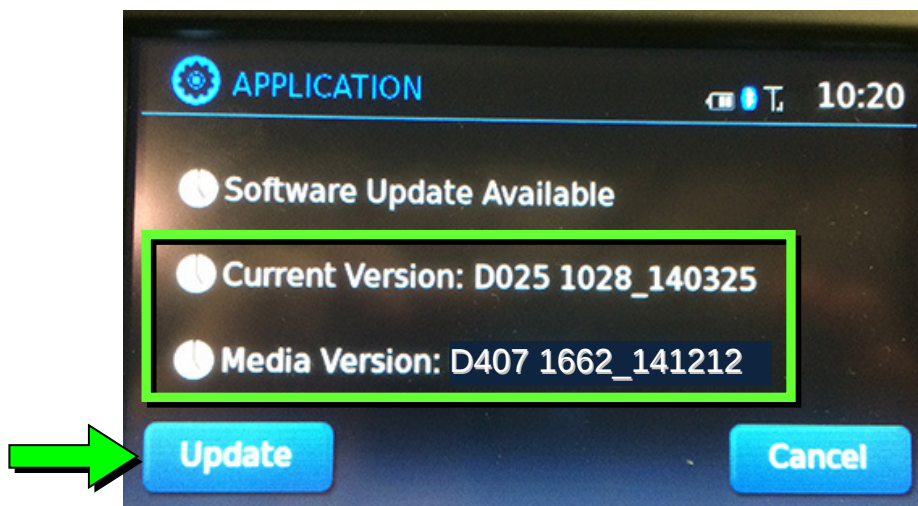
Figure 14

25. Wait for the **APPLICATION** screen to appear (Figure 14).

26. Confirm the **Current Version** and **Media Version** are different.

27. Select **Update**.

- After selecting **Update**, the screen will go black for up to one (1) minute. **This is a normal part of the update.**
