## SERVICE BULLETIN

EL20-008

### RADIO INTERMITTENTLY REBOOTS DURING AUDIO PLAYBACK VIA BLUETOOTH CONNECTED IPHONE

**APPLIED VEHICLES:** 2018-2019 Sentra (B17)  
2018-2019 Versa Note (E12) **with touch screen only**  
2018-2019 Versa Sedan (N17) **with touch screen only**  
2020 Versa Sedan (N18)  
2018-2020 Kicks (P15)

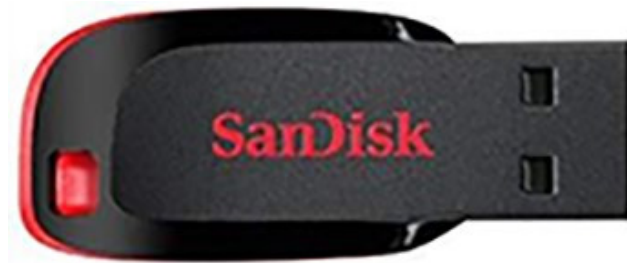
Figure 1

- One of special tool USB drive J-52727 has been shipped to each dealer (see Figure 1).
- Do not use any other USB drive to perform the procedure in this bulletin.
- Additional USB drives may be purchased from Tech•Mate: [nissantechmate.com](http://nissantechmate.com) or 1-800-662-2001.

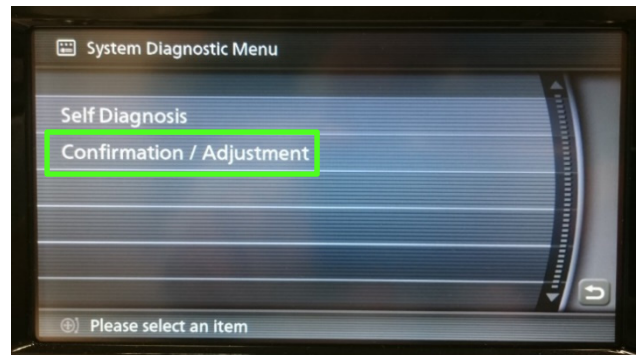
Figure 3

4. Select **Confirmation / Adjustment**.

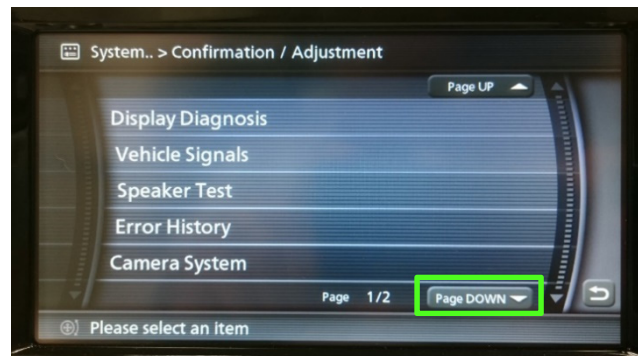
Figure 4

5. Select **Page DOWN**.

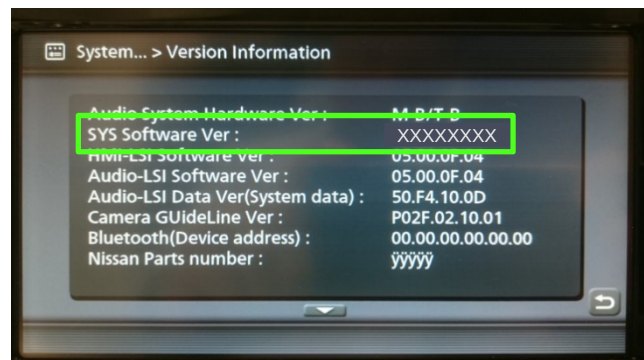
Figure 6

6. Select **Version Information**. Version information should display as shown in Figure 6.

- If the **SYS Software Version #** is less than the numbers shown below, turn the ignition OFF and continue to step 7 on page 4.
- If the **SYS Software Version #** is equal to or greater than the numbers shown below, no software update is needed. Go to ASIST for further diagnostic and repair information.

- o For 2018-2019 Sentra, Versa Note and Versa Sedan: 808**5**6035
- o For 2020 Versa Sedan and 2018- 2020 Kicks: 808**5**1035

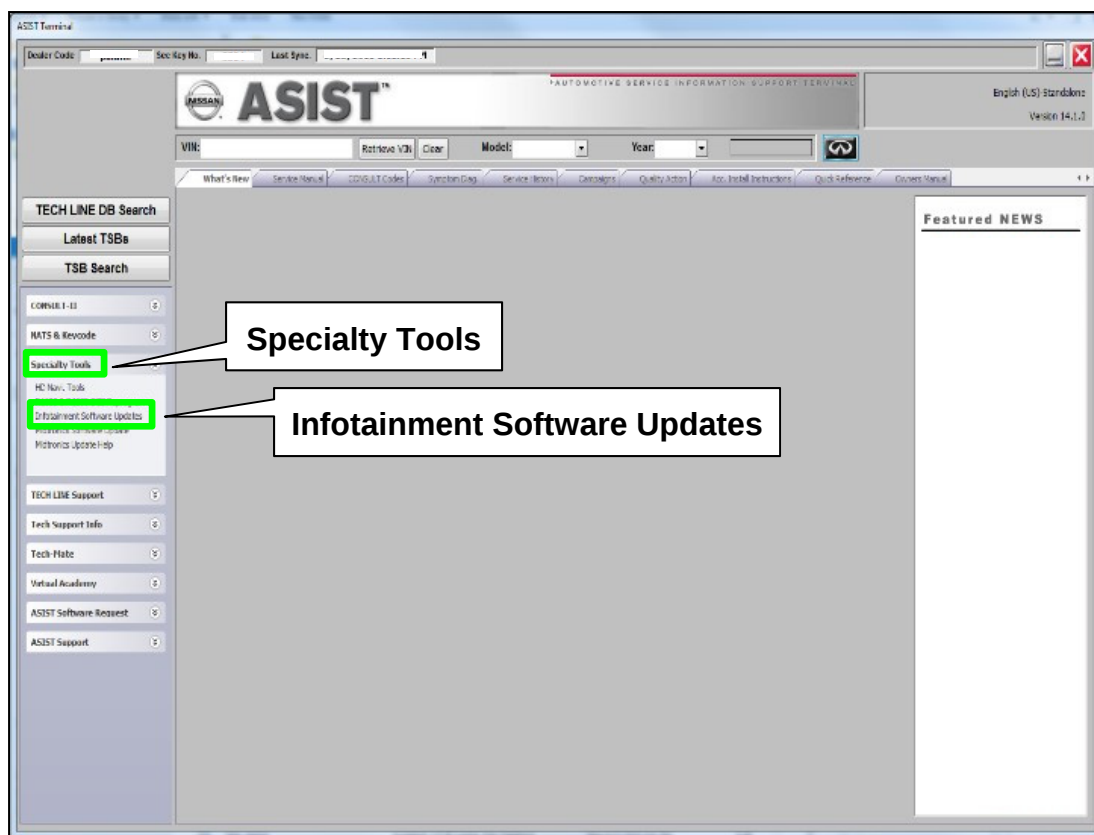
Figure 7

9. Select **Specialty Tools**, and then select **Infotainment Software Updates**.

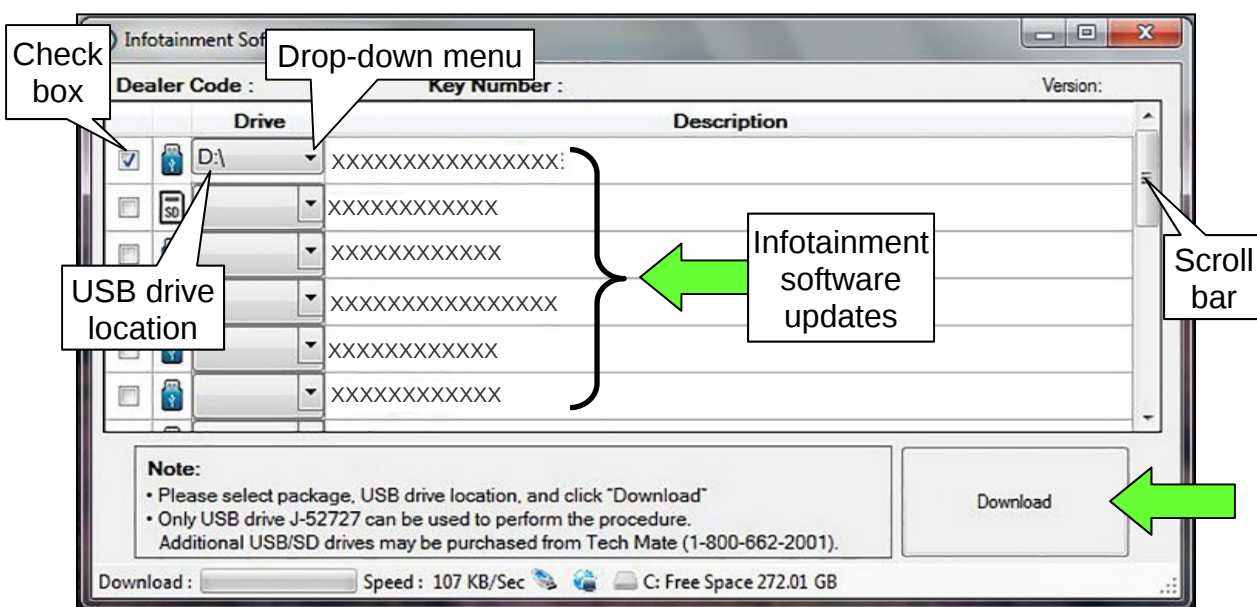
**Figure 8**

10. Select the check box next to the correct update software package (Figure 8).

- Locate update file #1 (LD001) and update file #2 (see Table A above).
- Only one (1) update will be loaded at a time, starting with update #1 (LD001).

11. Use the drop-down menu and select the location of the USB drive that was inserted in step 7 on page 4.

**HINT:** The **Description** section in Figure 8 may be different than on your C-III plus screen.

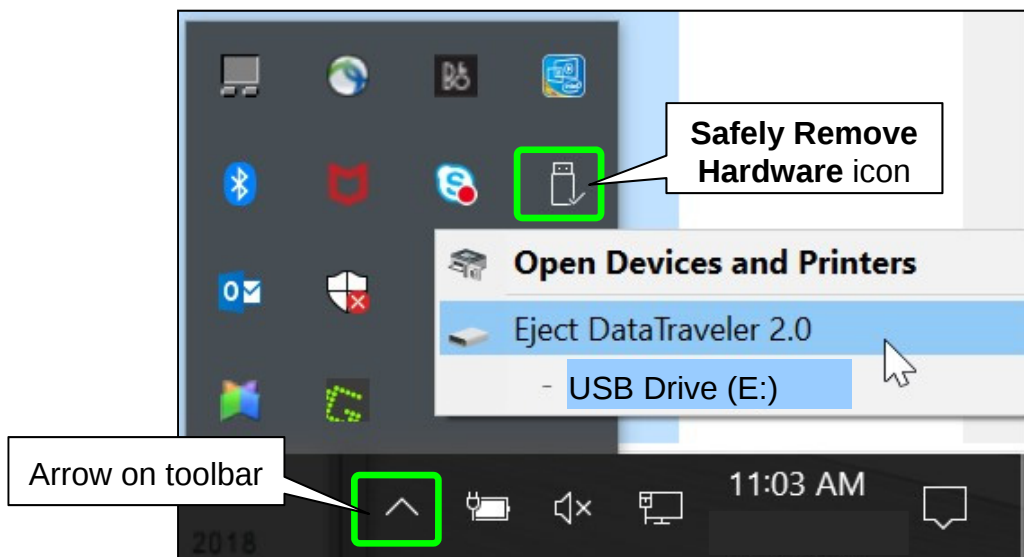
Figure 10

14. Once the transfer is complete, safely remove the USB drive from the ASIST station.
  - a. From the PC toolbar, select the **Safely Remove Hardware** icon.
    - The icon is on the toolbar, or to be found after selecting the arrow.
  - b. Select the USB drive to be removed, and then remove the USB drive from the ASIST station.

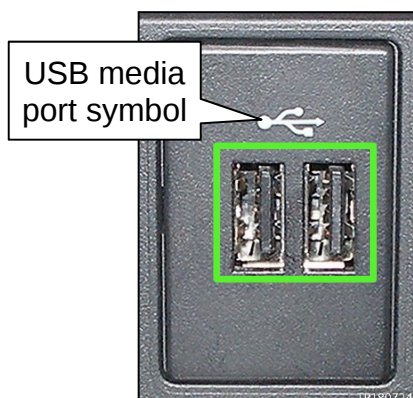
Figure 11

20. Turn OFF the audio system.
21. Insert the special tool USB drive J-52727 into the USB media port (Figure 11).

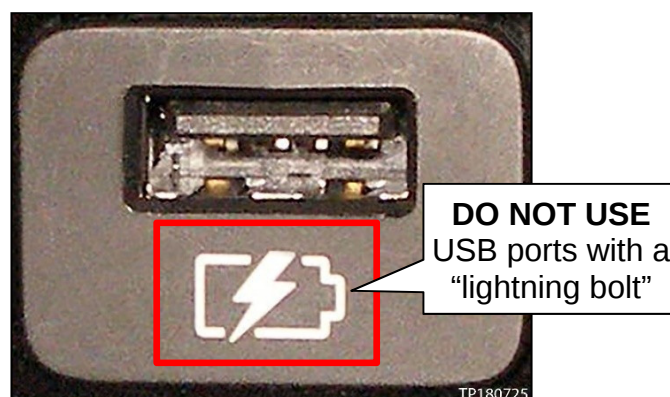
Figure 12

**NOTICE** Do not insert the USB drive into a charging port (Figure 12). If used, the update software and/or USB drive may become damaged. Only insert the USB drive in a USB media port.

**HINT:** Charging ports are marked in the vehicle with a “lightning bolt” symbol.

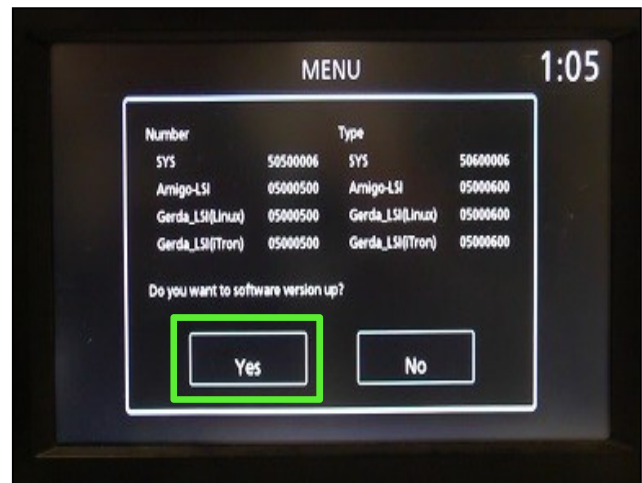
Figure 13

22. Select **Yes** to begin the reprogramming process.

**HINT:** Reprogramming will take about 5-10 minutes.

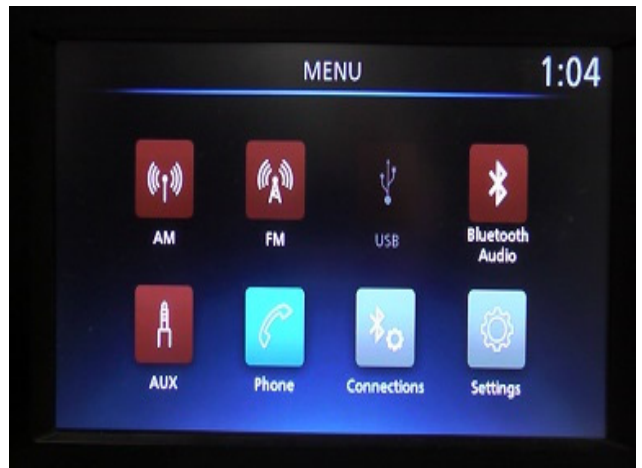
Figure 14

**HINT:** Reprogramming is not complete until the audio unit reboots and returns to the main MENU screen (Figure 14).

**NOTICE** To prevent damage to the AV control unit, do NOT remove the USB drive unless the audio unit has rebooted and the main MENU screen, as shown in Figure 14, is displayed.
