SERVICE BULLETIN

Classification:	Reference:	Date:
AN21-009A	NTB21-046A	June 18, 2021

SOFTWARE UPDATE FOR INFOTAINMENT ISSUES

APPLIED VEHICLES: 2020-2021 Titan/Titan XD (A61)

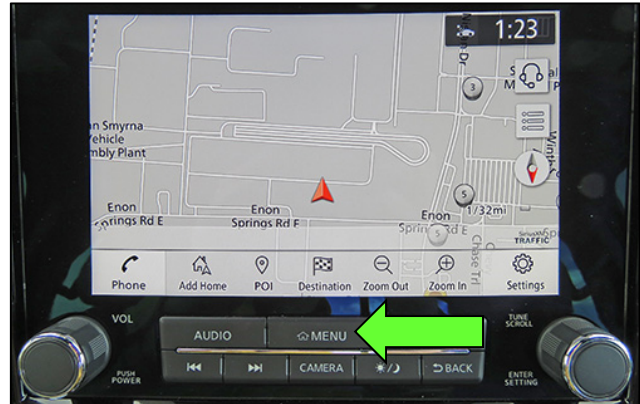
Figure 2

1. Push the **MENU** button.

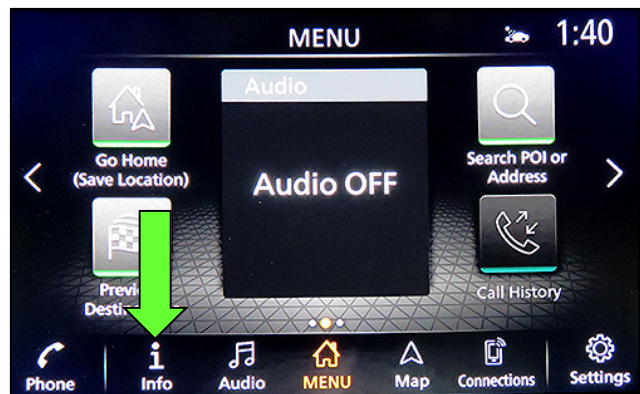
Figure 3

2. Select the **Info** Icon.
 - If the **Info** icon does not appear as shown in Figure 3, this bulletin does not apply.

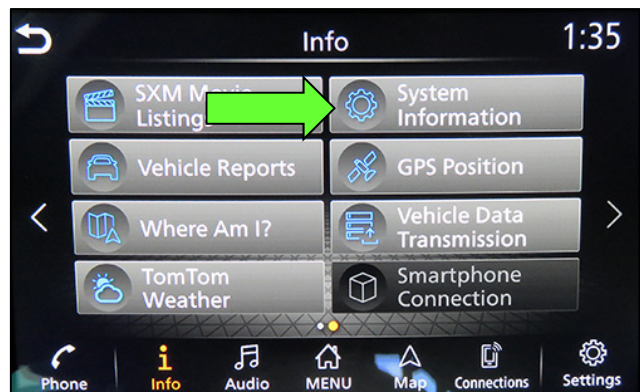
Figure 4

3. Select **System Information** to access the vehicle update menu.

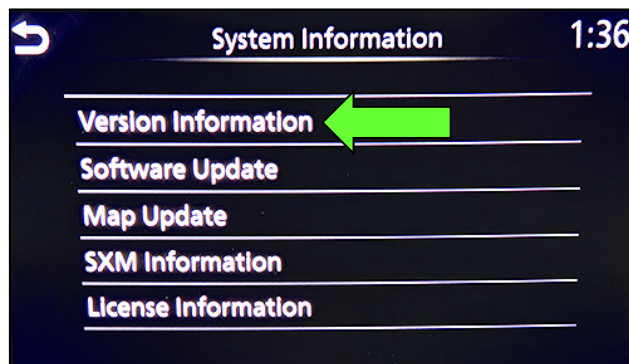
Figure 5

4. Select **Version Information**.

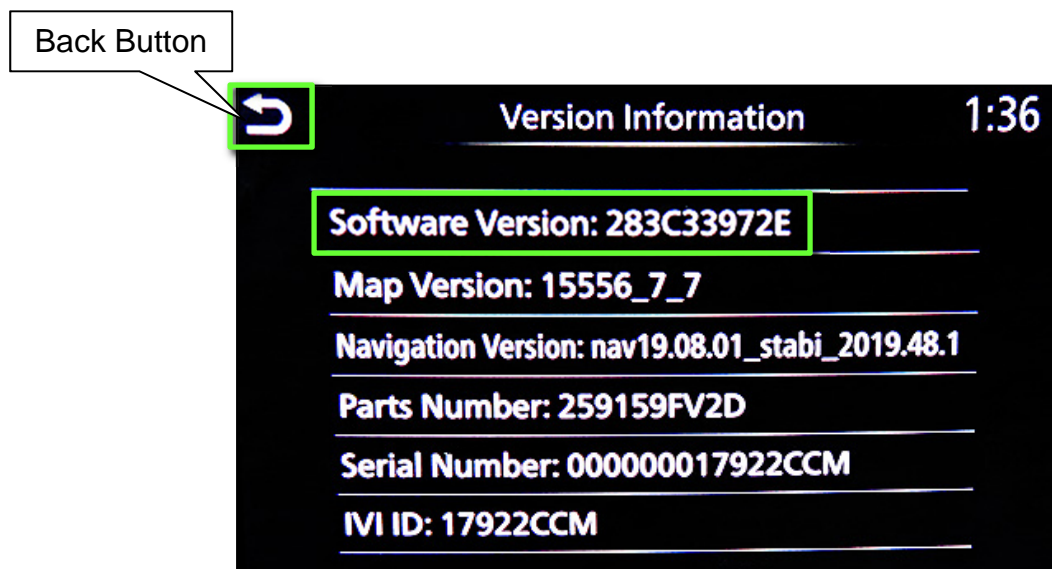
Figure 6

- If the Software Version is the version listed in **Table A**, select the back button and continue to step 5 on the next page.
- If the Software Version is NOT the version listed in **Table A**, select the back button, this bulletin **does not apply**.

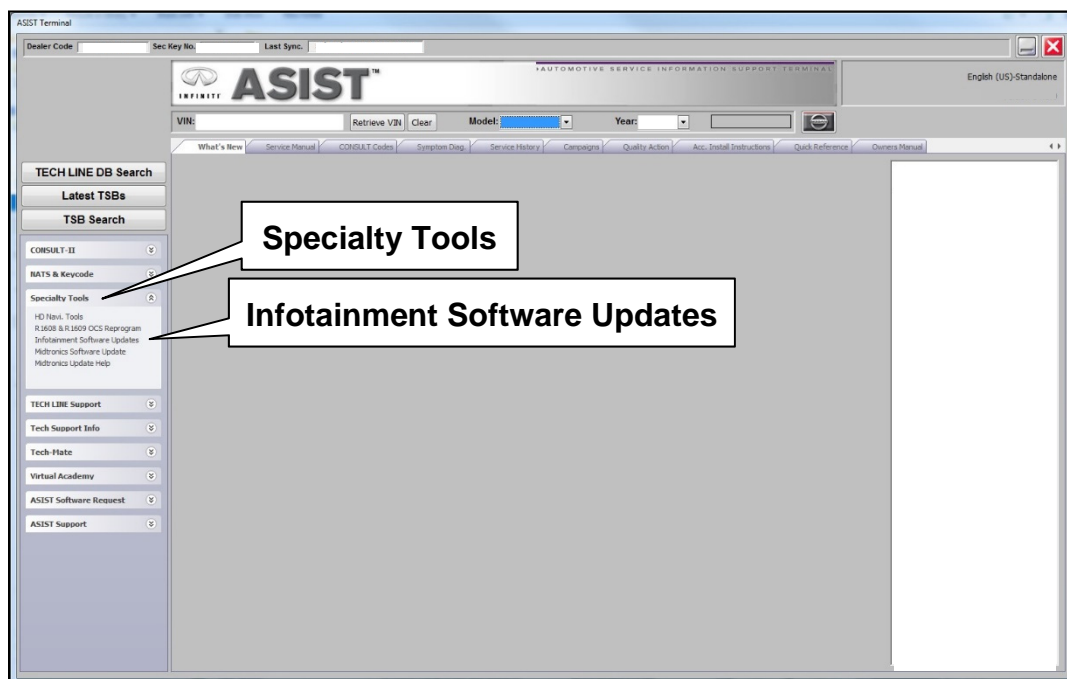
Figure 7

7. Select **Specialty Tools**, and then select **Infotainment Software Updates**.

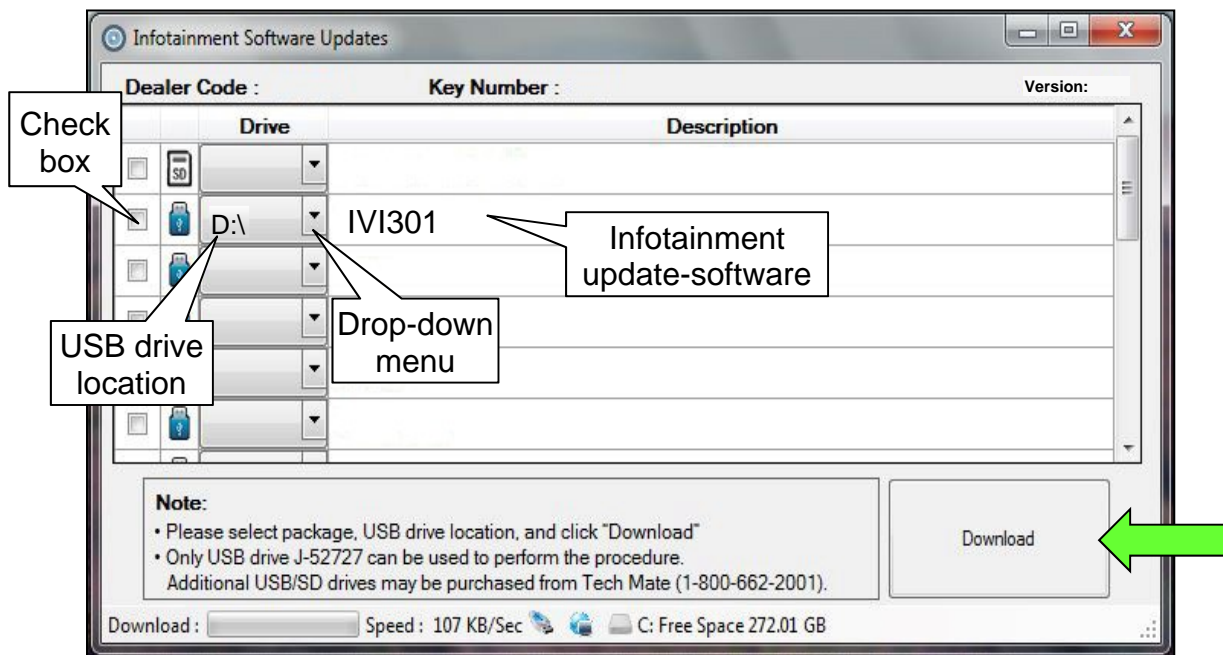
Figure 8

8. Select the check box next to infotainment update-software IVI301 (Figure 8).
9. Use the drop-down menu and select the location of the USB drive that was inserted in step 5.

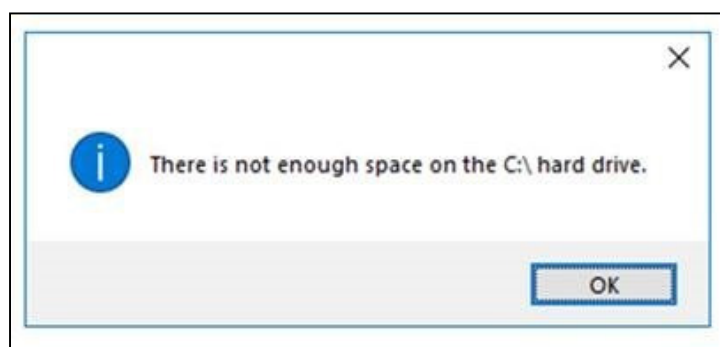
Figure 9

- The update-software is estimated to take 4 hours to download to the USB drive.
- If, while attempting to download the software to the ASIST Station, you receive the message shown in Figure 9:
 - a. First, attempt to clear space on the ASIST Station hard drive.
 - b. If space on the hard drive cannot be cleared, email Bosch at **nissan.dealers@us.bosch.com** for additional options.

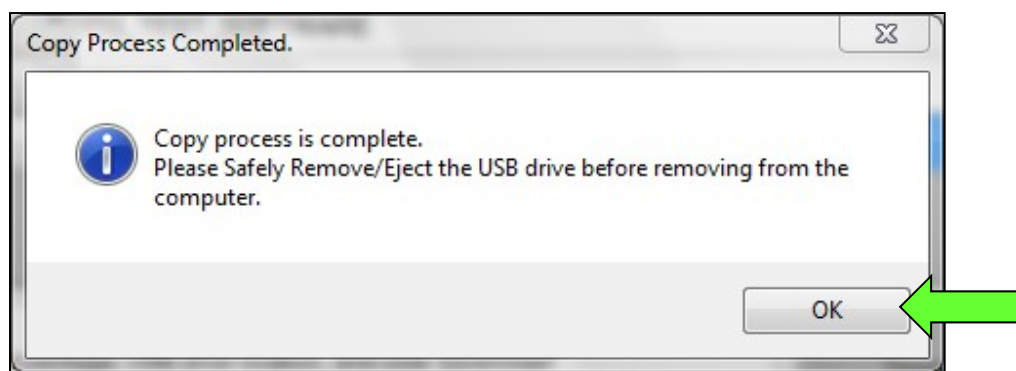
Figure 10

11. Select **OK**.

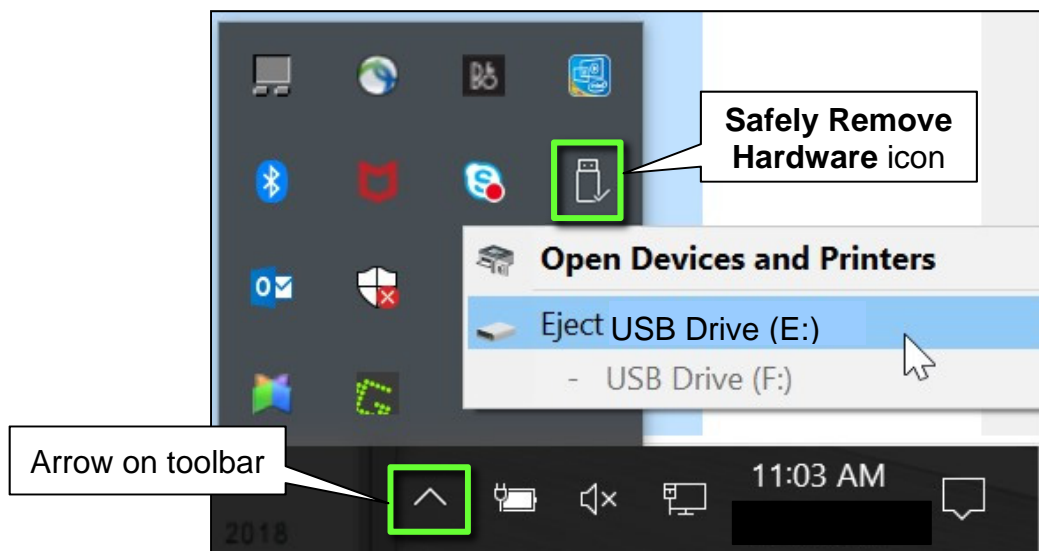
Figure 11

12. Once the transfer is complete, safely remove the USB drive from the ASIST Station.
 - a. From the PC toolbar, select the **Safely Remove Hardware** icon.
 - The icon is on the toolbar, or can be found after selecting the arrow.
 - b. Select the USB drive to be removed, and then remove the USB drive from the ASIST Station.

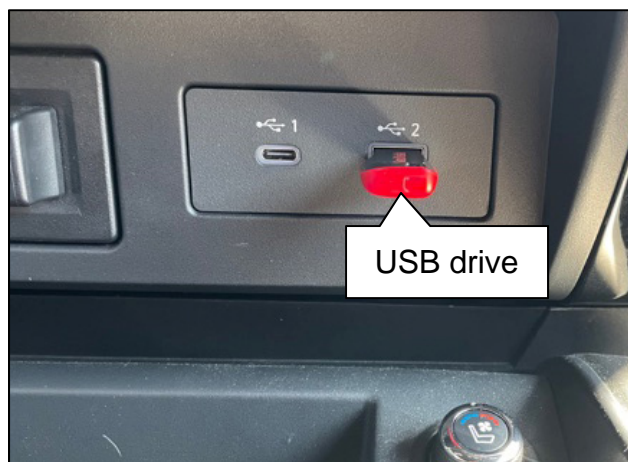
Figure 12

16. Insert the USB drive with the infotainment update-software into the vehicle's USB media port (see Figure 12).

NOTICE Do not insert the USB drive into a charging port. If used, the update-software and/or USB drive may become damaged. Only insert the USB drive in a USB media port.

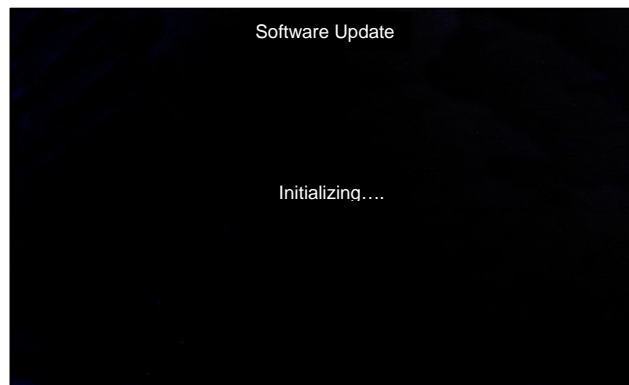
17. Wait approximately 10-30 seconds for the screen in Figure 13 to appear.

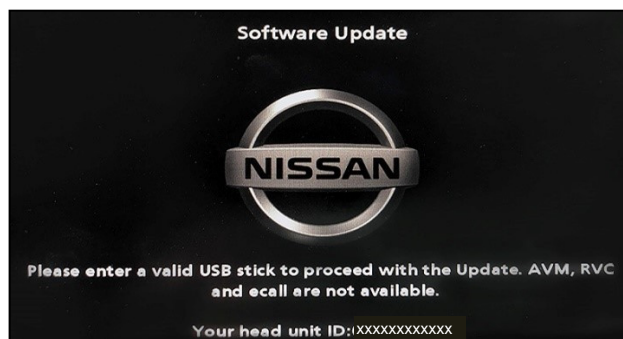
- The screen in Figure 14 may briefly appear. **Do not remove the USB drive.** The audio system will detect the USB and continue the update.

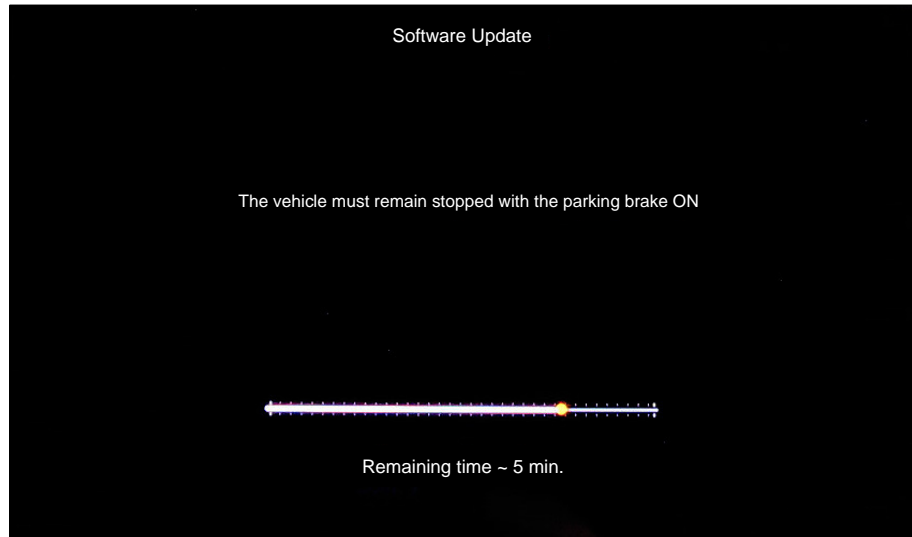
Figure 15

18. Wait for the update to complete.
- Follow the on-screen instructions while waiting.
- HINT:** The update may take 15-25 minutes.

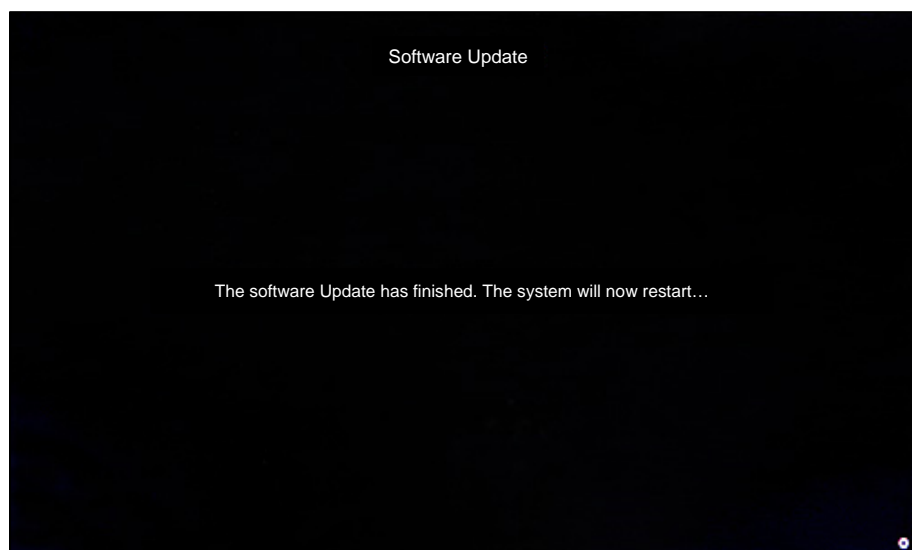
Figure 16

19. Once the update is complete (Figure 16), remove the USB drive; the system will reboot (restart).
- HINT:** The system will not reboot until the USB drive is removed.

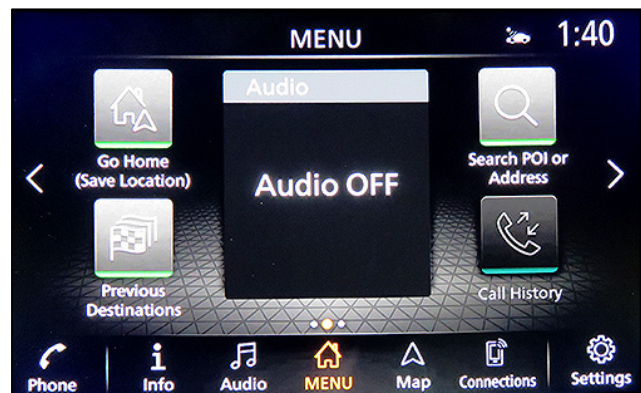
25. After the Nissan logo appears, wait about 1 minute.
 - The MENU (Home) screen in Figure 18 will be displayed.
