# SERVICE BULLETIN

AN21-018

## HIGH FREQUENCY NOISE WITH AUDIO SYSTEM DISPLAY ON

**APPLIED VEHICLES:** 2021 Kicks (P15)**APPLIED TRIM LEVEL:** SV, SR

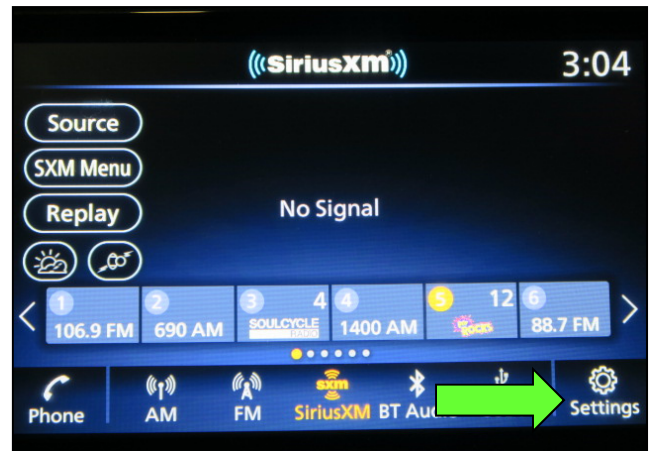
Figure 2

1. Select **Settings**, located in the lower right hand corner of the Audio Control Unit display shown in Figure 2.

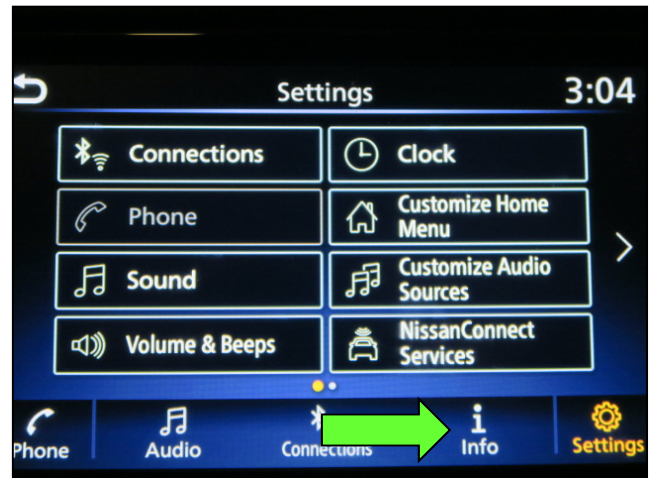
Figure 3

2. Select **Info**.

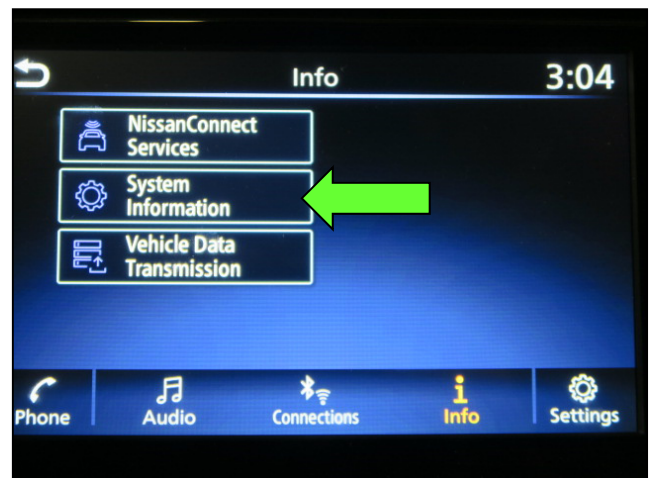
Figure 4

3. Select **System Information**.

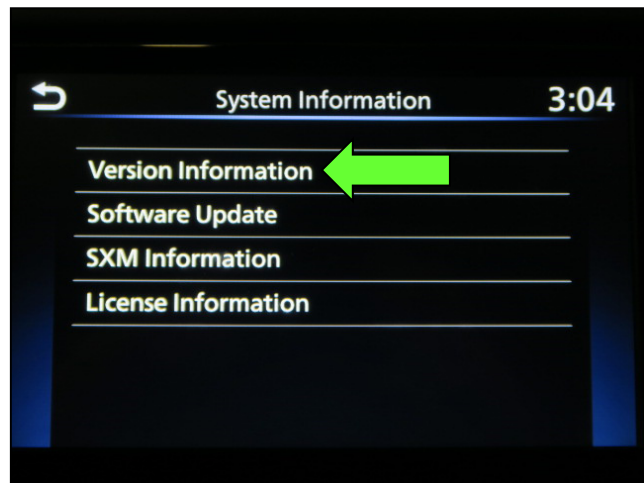
Figure 5

4. Select **Version Information**.

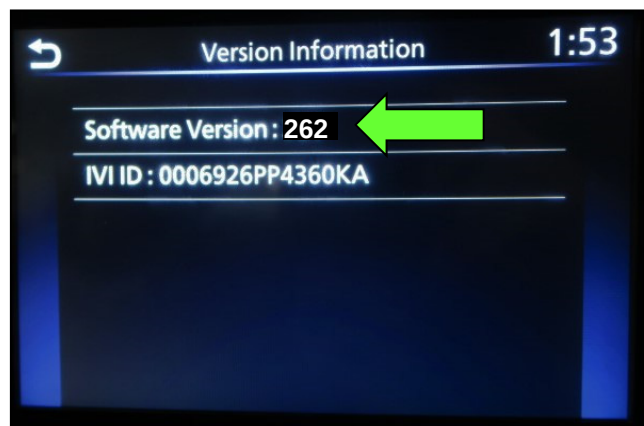
Figure 6

5. Confirm current Audio Control Unit software level is numerically below software version **423**.
- If the software level is numerically below software version **423**, proceed to step 6 on page 5.
  - If the software version is not numerically below software version **423**, the service procedure is complete. Proceed to **CLAIMS INFORMATION** on the last page of this bulletin.

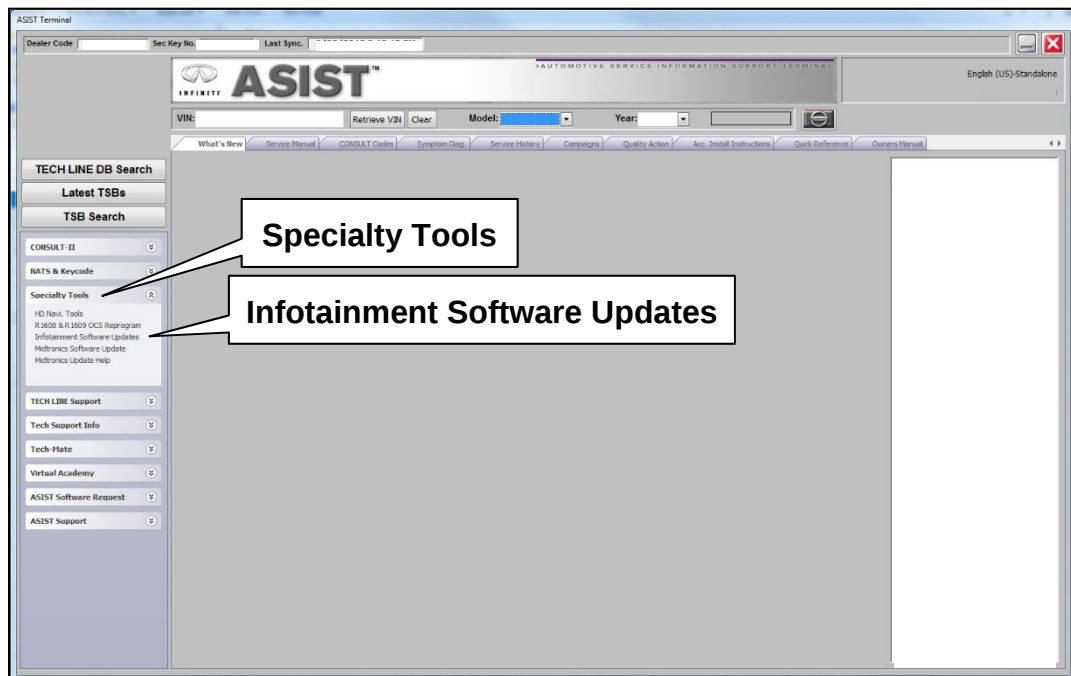
Figure 7

### 8. Select **Specialty Tools**, and then select **Infotainment Software Updates**.

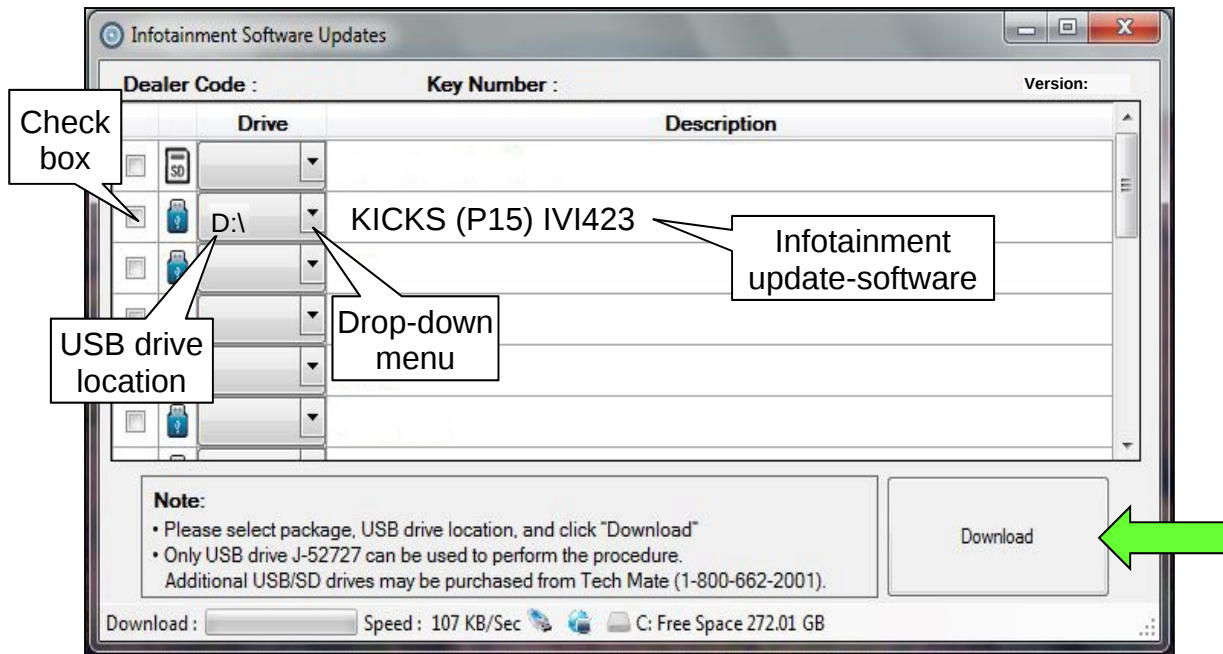
Figure 8

9. Select the check box next to infotainment update-software as “KICKS (P15) IVI423” (Figure 8).
10. Use the drop-down menu and select the location of the USB drive that was inserted in step 6.

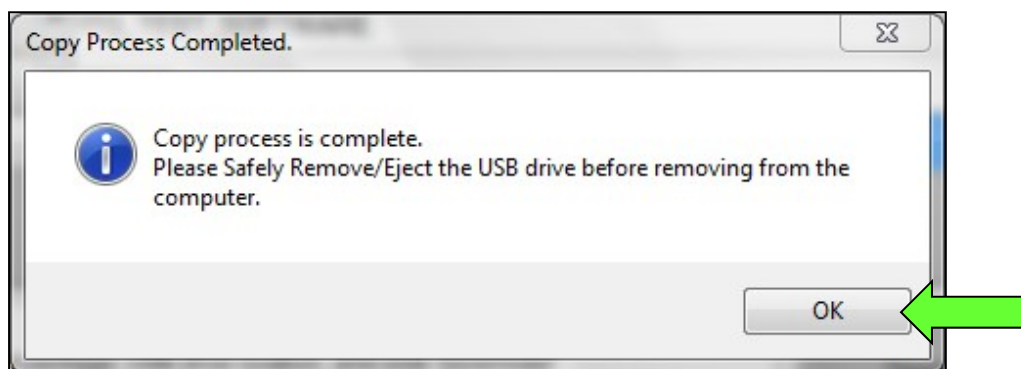
11. Select **Download**, and then wait for the download to complete.  
**HINT:** The update-software is estimated to take 10-15 minutes to download to the USB drive.
12. Select **OK** when the message in Figure 9 is displayed.

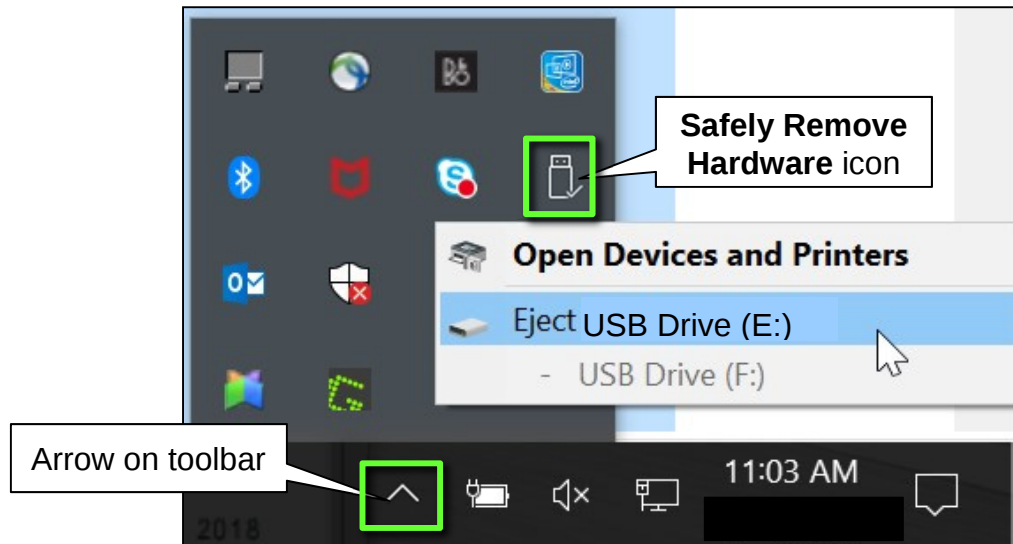
Figure 10

13. Once the transfer is complete, safely remove the USB drive from the CONSULT PC.

- a. From the PC toolbar, select the **Safely Remove Hardware** icon.
  - o The icon is on the toolbar, or can be found after selecting the arrow.
- b. Select the USB drive to be removed, and then remove the USB drive from the CONSULT PC.

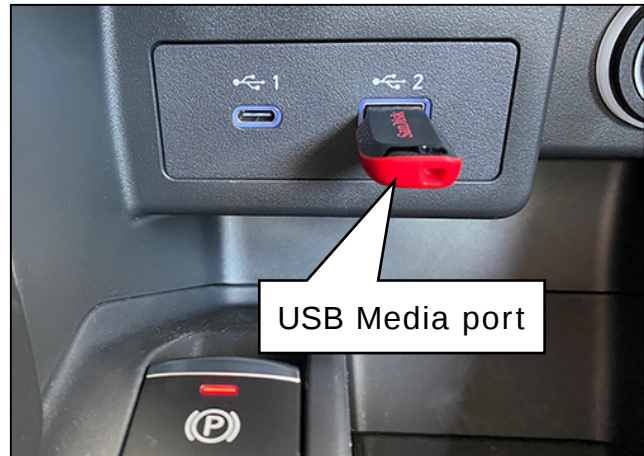
Figure 11

17. Insert the USB drive with the infotainment update-software into the vehicle's USB media port (Figure 11).

- Do not remove the USB drive during the update to the vehicle until instructed to.

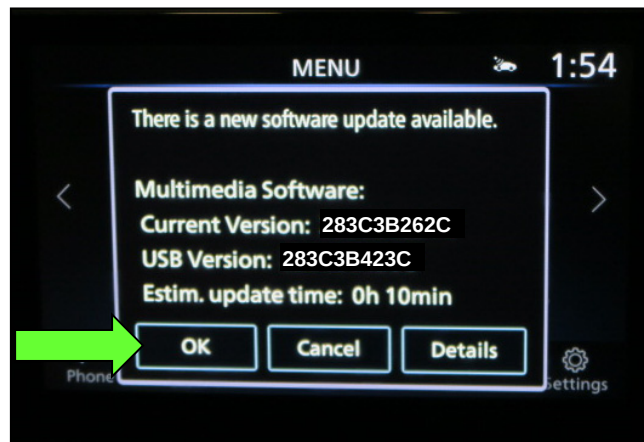
18. Wait approximately 10-30 seconds for the screen in Figure 12 to appear, and then select **OK**.

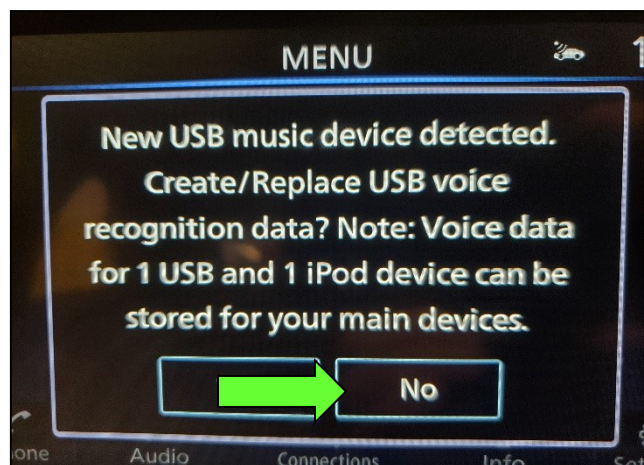
- If the screen in Figure 13 is shown, select **No**.

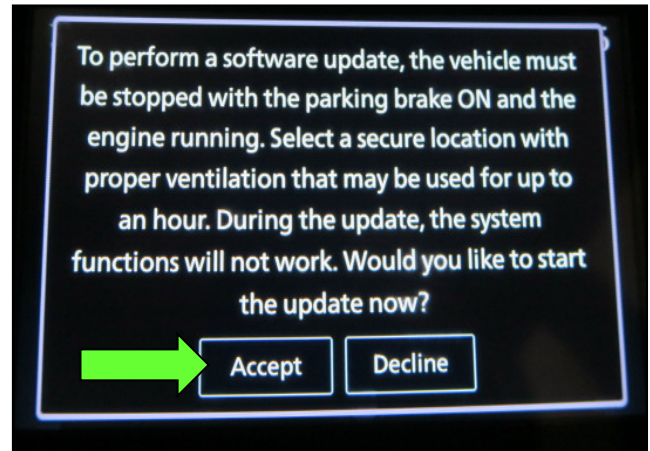
Figure 14

19. Review the software update requirements, shown in Figure 14, and then select **Accept** to start the reprogramming.

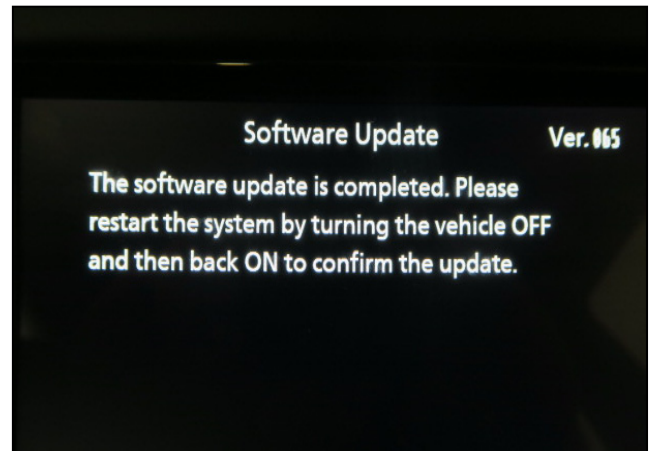
20. When the message shown in Figure 15 is displayed, remove the USB drive from the USB media port.

Do not remove the USB drive until the screen in Figure 15 is displayed. If removed prior to this screen being displayed, the Audio Control Unit may be damaged.

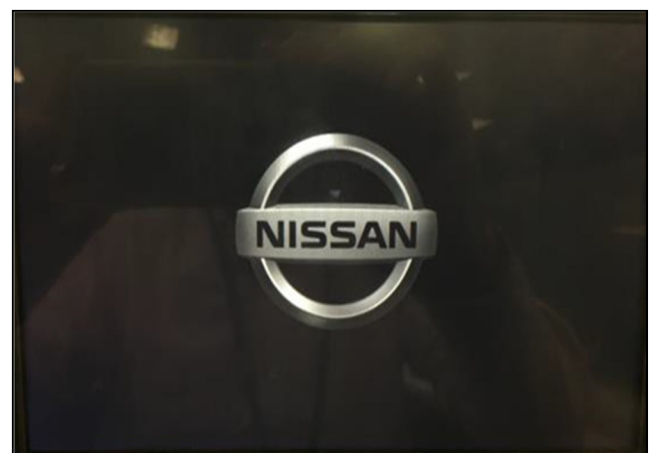
Figure 16

24. Allow the system to boot up completely (approximately 30 seconds).
- The Nissan logo will be displayed during the reboot (Figure 16).

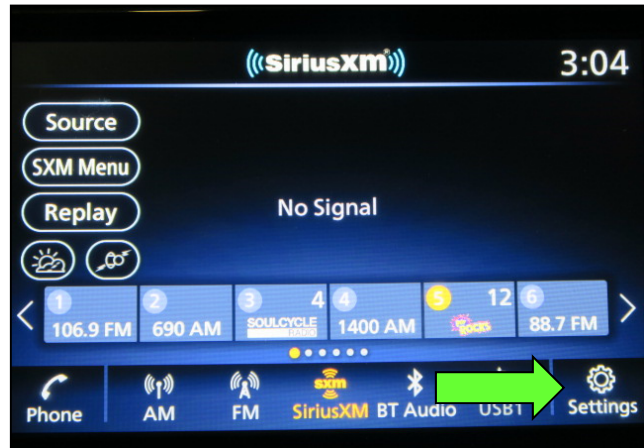
Figure 17

25. Select **Settings**, located in the lower right hand corner of the AV unit display shown in Figure 17.

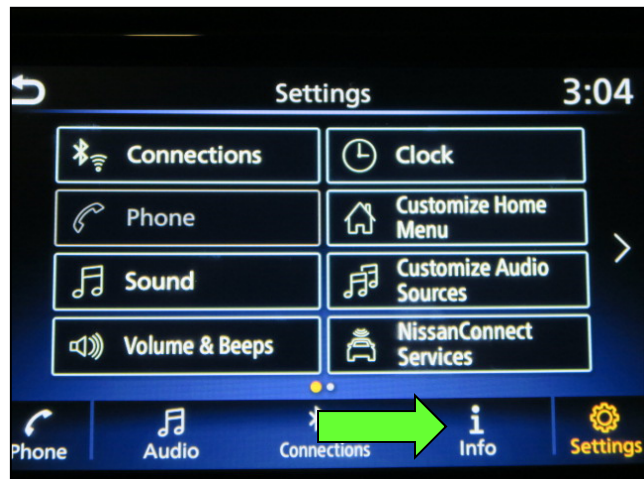
Figure 18

26. Select **Info**.

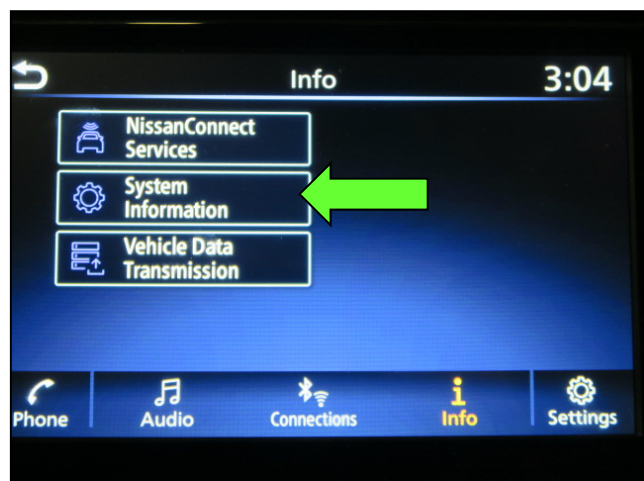
Figure 19

27. Select **System Information**.

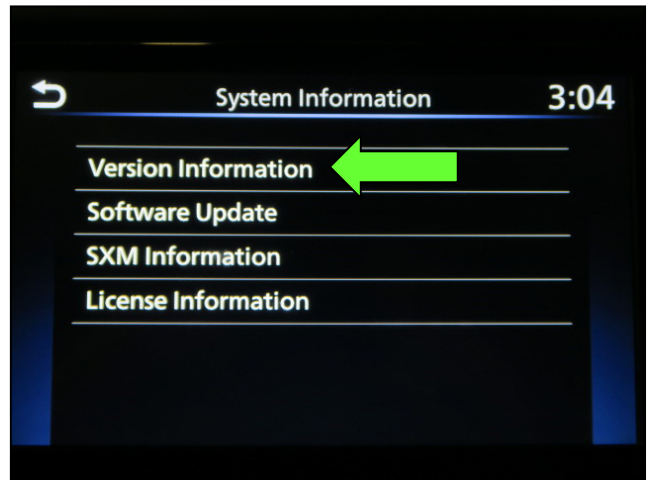
Figure 20

28. Select **Version Information**.

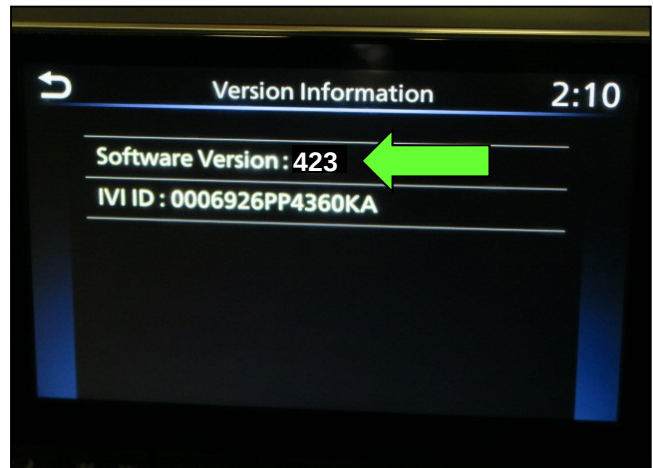
Figure 21

29. Verify the Software Version is now **423**.
- If the software version is NOT 423, start this procedure over and verify that the correct software shown in step 9 on page 6 is downloaded.
  - If the software version is 423, the reprogramming is complete.
