# SERVICE BULLETIN

| AN21-024 | NTB21-119 | December 20, 2021 |

## INFOTAINMENT SYSTEM CONSTANTLY REBOOTS EVERY 4-5 MINUTES

**APPLIED VEHICLES:** 2021 Rogue (T33)  
**APPLIED GRADES:** SV vehicles that are, or were, part of a rental fleet

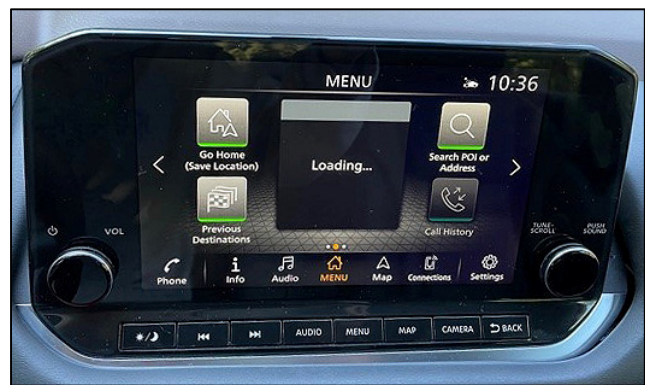
- The MENU (Home) screen in Figure 14 will be displayed.
