# TECHNICAL SERVICE BULLETIN

| AN22-001 | NTB22-028 | April 13, 2022 |

## SOFTWARE UPDATE FOR INFOTAINMENT ISSUES

**APPLIED VEHICLES:** 2021 Kicks (P15)  
2021 Sentra (B18)

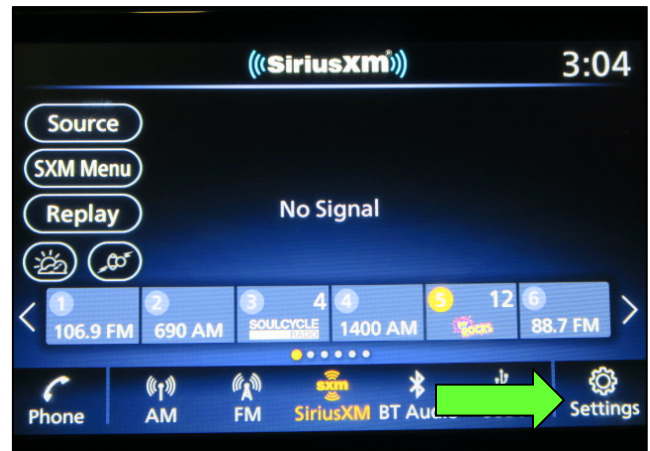
Figure 2

1. Select **Settings**, located in the lower right hand corner of the Audio Control Unit display (Figure 2).

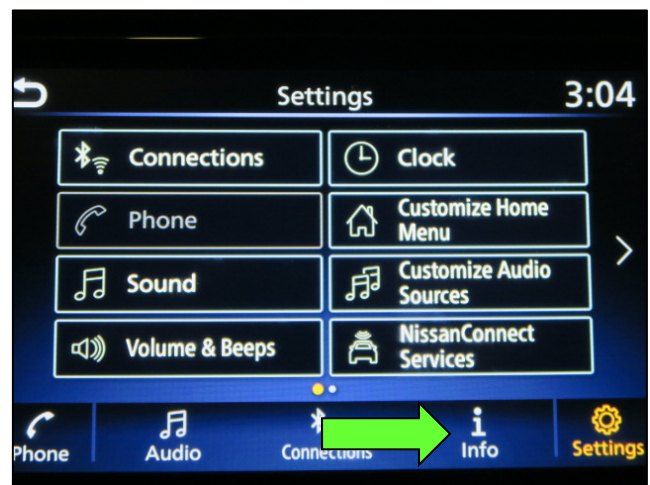
Figure 3

2. Select **Info**.

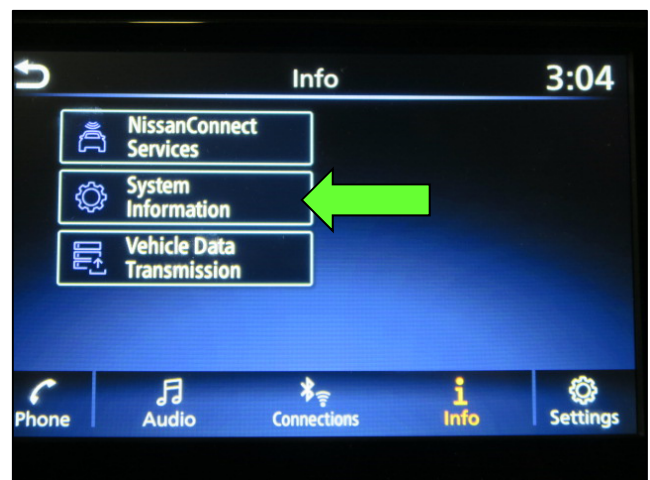
Figure 4

3. Select **System Information**.

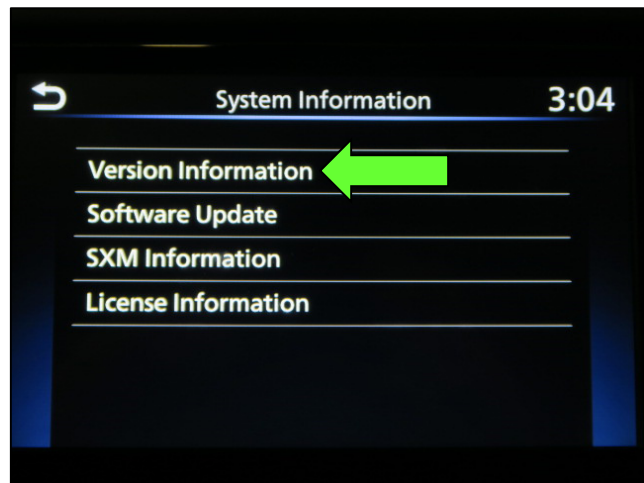
Figure 5

4. Select **Version Information**.

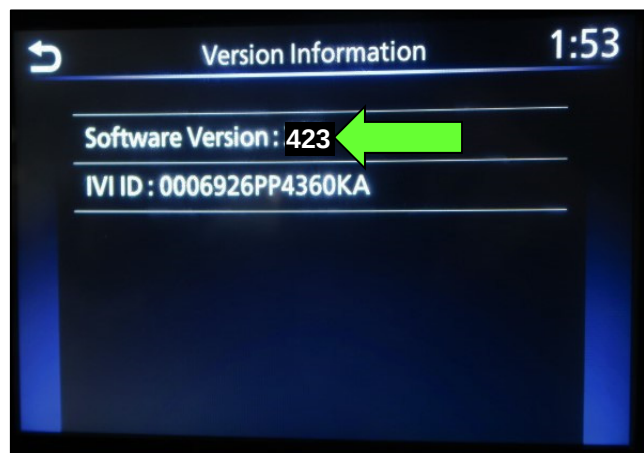
Figure 6

5. Verify the **Software Version** is numerically below 423.
- If the **Software Version** is below 423, proceed to step 6 on page 5.
  - If the **Software Version** is not below 423, the **SERVICE PROCEDURE** is complete. Proceed to **CLAIMS INFORMATION** on the last page of this bulletin.

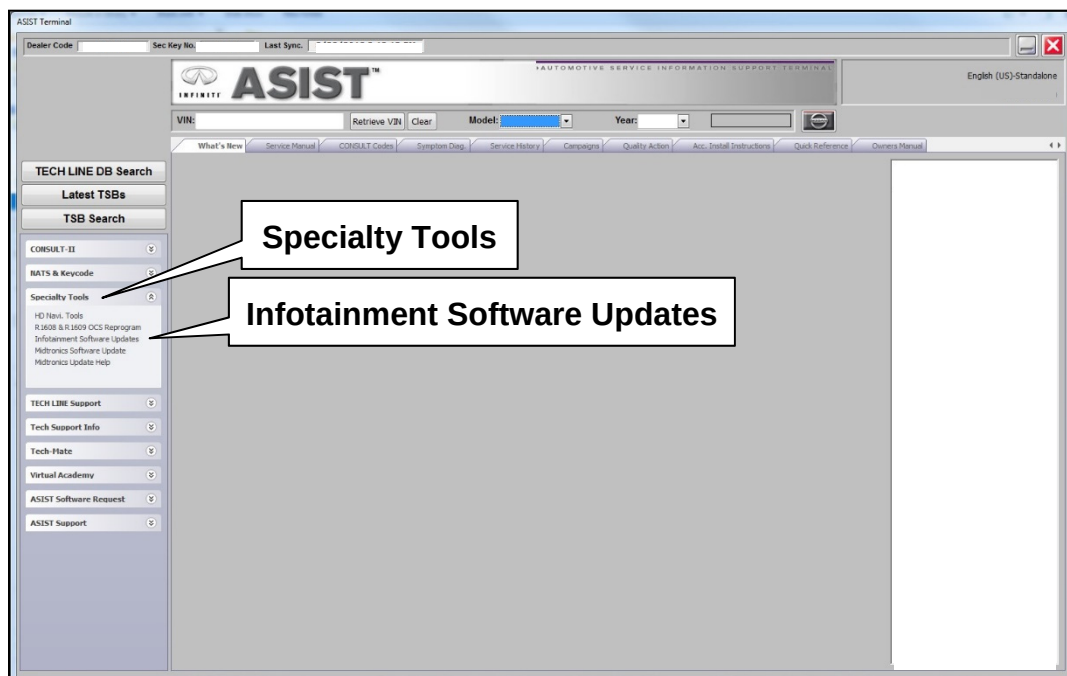
Figure 7

### 8. Select **Specialty Tools**, and then select **Infotainment Software Updates**.

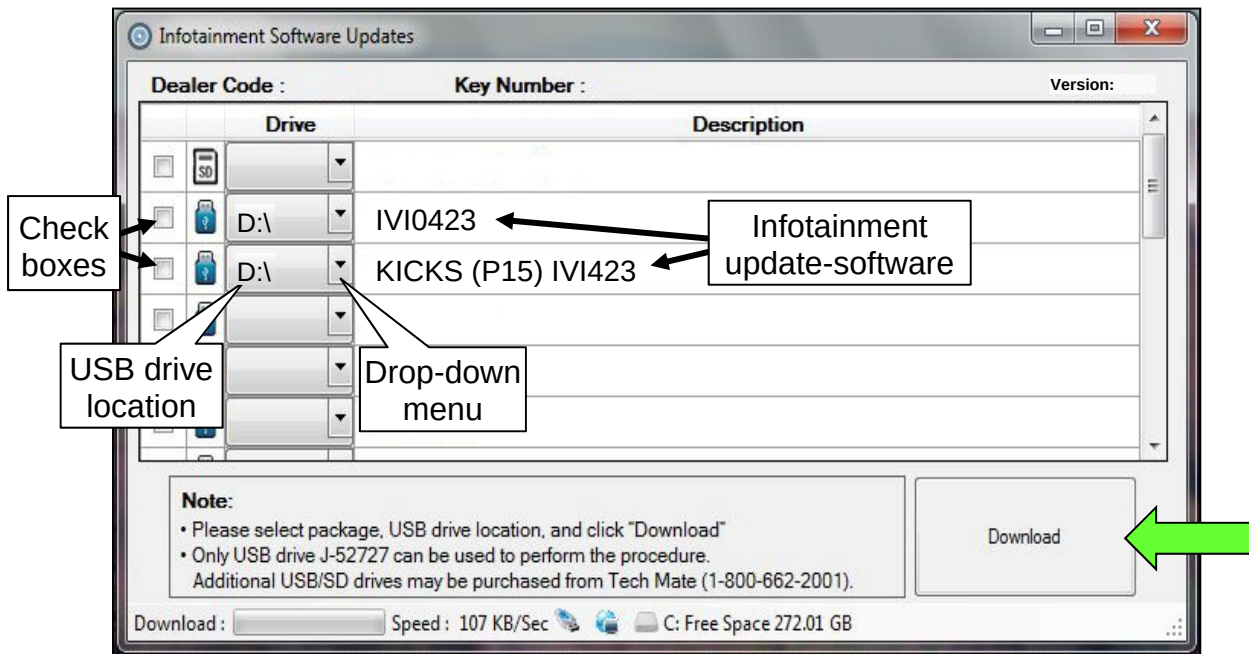
Figure 8

9. Select the check box next to one of the following model specific infotainment update-software descriptions:
  - For Sentra – **IVI0423**
  - For Kicks – **KICKS (P15) IVI423**
10. Use the drop-down menu and select the location of the USB drive that was inserted in step 6 on page 5.

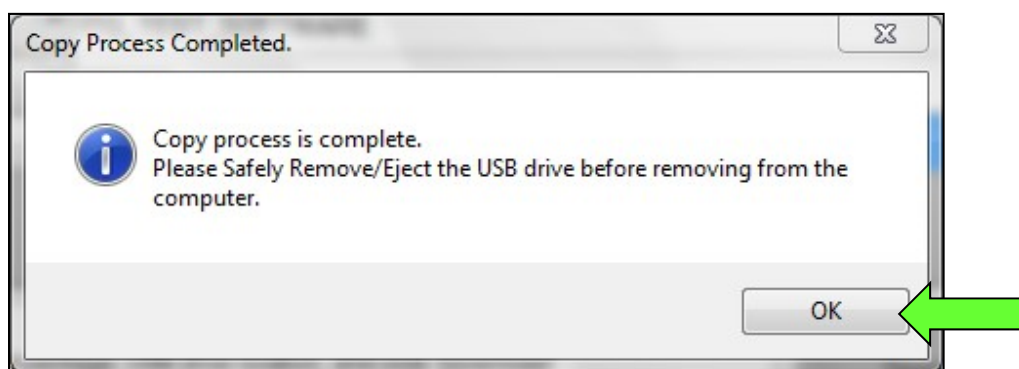
11. Select **Download**, and then wait for the download to complete.  
**HINT:** The update-software is estimated to take 10-15 minutes to download to the USB drive.
12. Select **OK** when the message in Figure 9 is displayed.

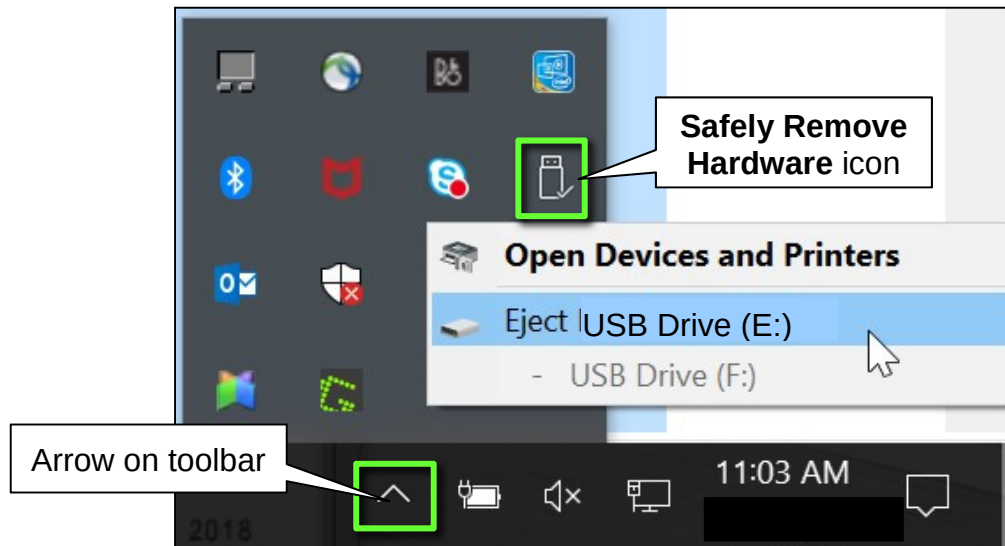
Figure 10

- a. From the PC toolbar, select the **Safely Remove Hardware** icon.
  - o The icon is on the toolbar, or can be found after selecting the arrow.
- b. Select the USB drive to be removed, and then remove the USB drive from the CONSULT PC.

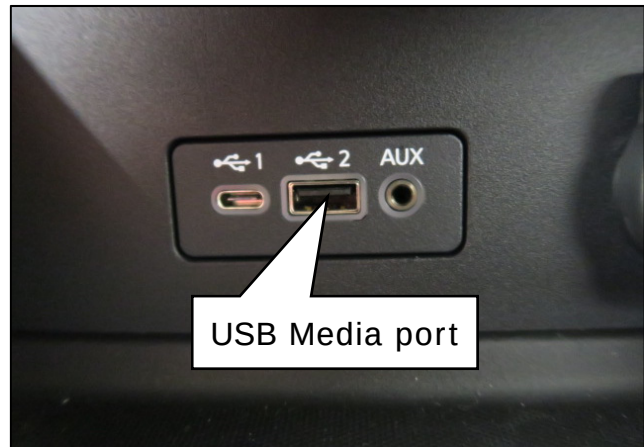
Figure 11

17. Insert the USB drive with the infotainment update-software into the vehicle's USB media port (Figure 11).
  - Do not remove the USB drive during the update to the vehicle until instructed to do so.

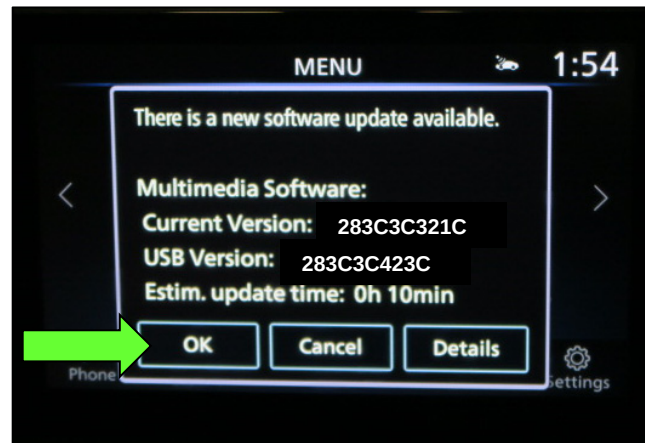
18. Wait approximately 10-30 seconds for the screen in Figure 12 to appear, and then select **OK**.

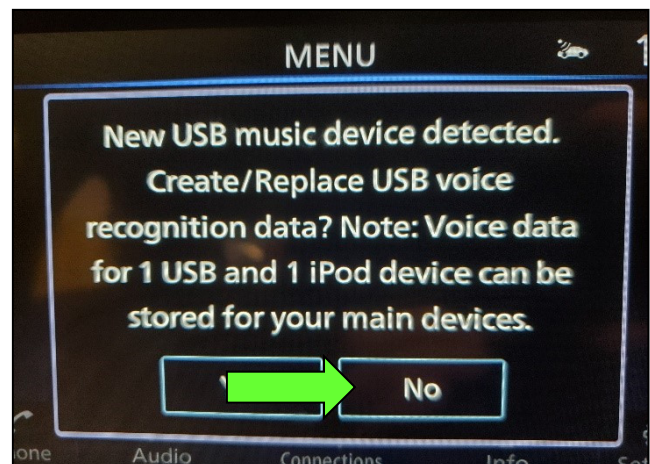
- If the screen in Figure 13 is shown, select **No**.

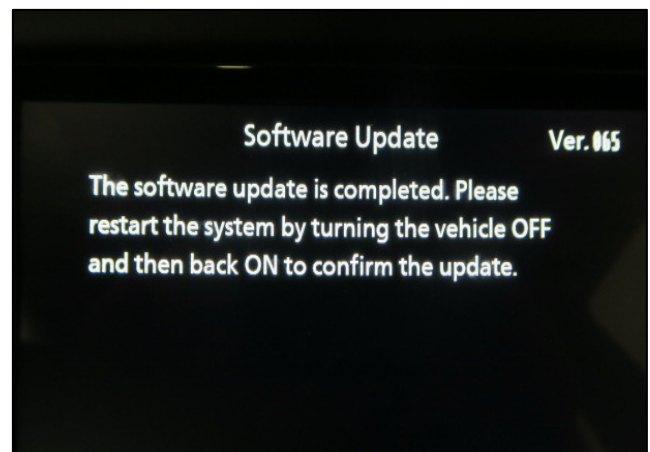
20. When the message shown in Figure 15 is displayed, remove the USB drive from the USB media port.

Do not remove the USB drive until the screen in Figure 15 is displayed. If removed prior to this screen being displayed, the Audio Control Unit may be damaged.

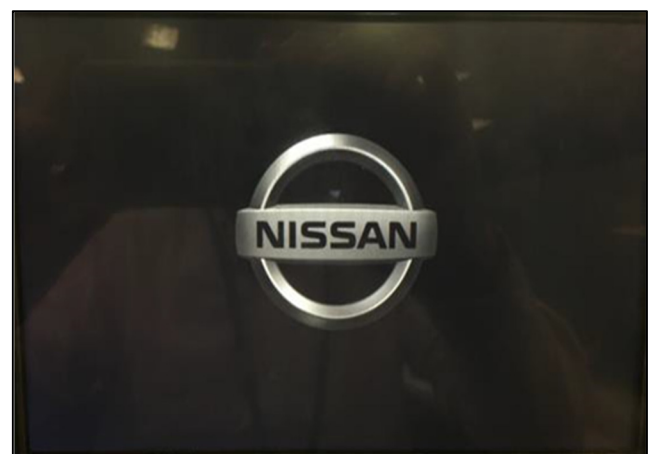
Figure 16

21. Turn the ignition OFF.
22. Open and close the driver door.
23. Restart the engine.
24. Allow the system to boot up completely (approximately 30 seconds).
- The Nissan logo will be displayed during the reboot (Figure 16).

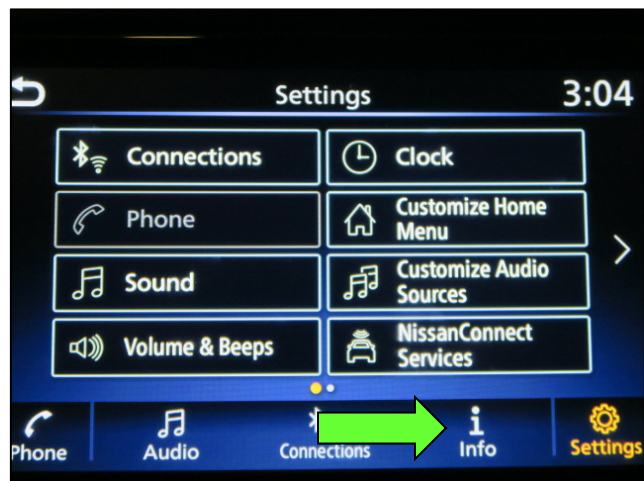
Figure 18

26. Select **Info**.

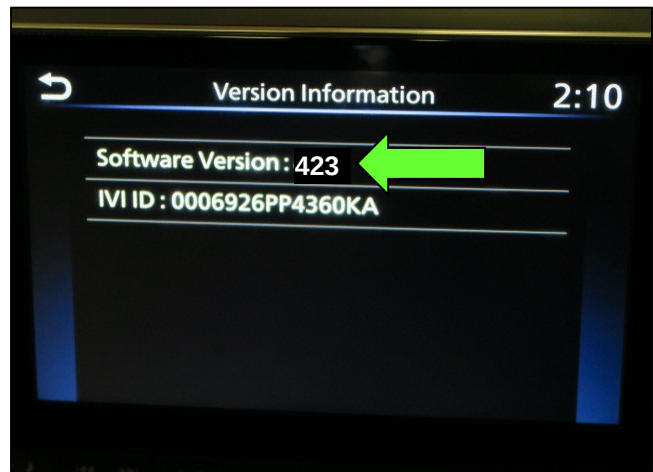
Figure 21

29. Verify the **Software Version** is now **423**.

- If the **Software Version** is NOT **423**, start this procedure over and verify that the correct software shown in step 9 on page 6 is downloaded.
- If the **Software Version** is 423, the reprogramming is complete.
