# TECHNICAL SERVICE BULLETIN

| AN22-004 | NTB22-029 | April 14, 2022 |

## SOFTWARE UPDATE FOR INFOTAINMENT ISSUES

**APPLIED VEHICLES:** 2022 Frontier (D41) – S and SV only  
2022 LEAF (ZE1) – S only

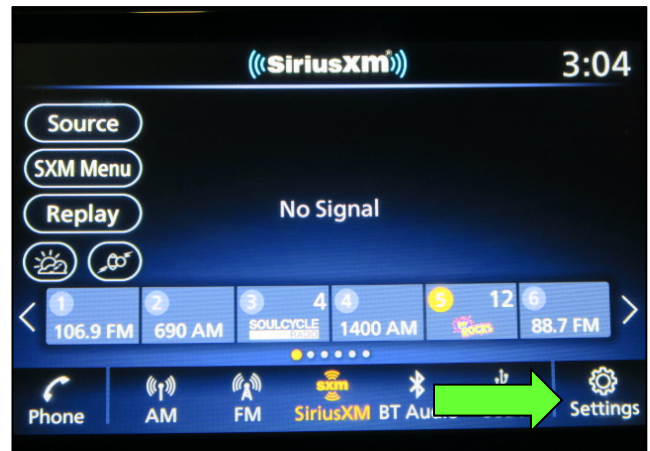
Figure 2

1. Select **Settings**, located in the lower right hand corner of the AV control unit display (Figure 2).

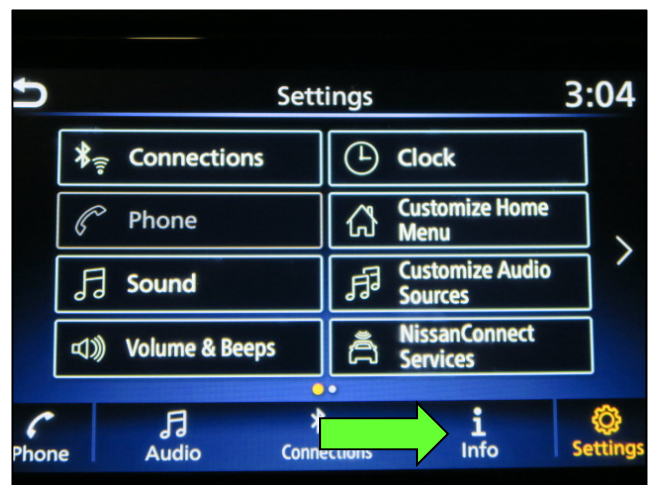
Figure 3

2. Select **Info**.

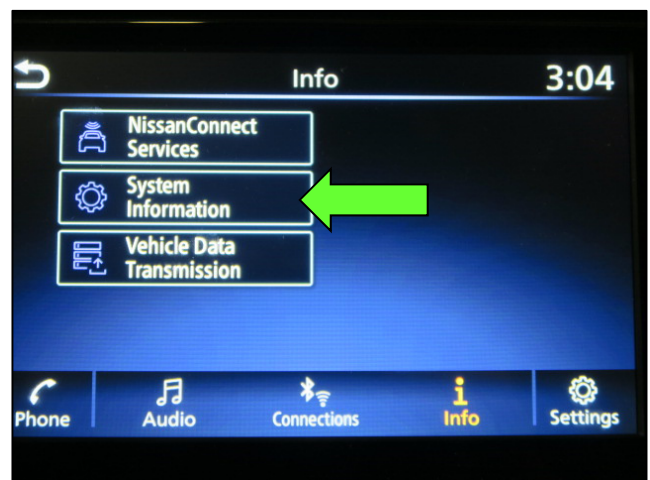
Figure 4

3. Select **System Information**.

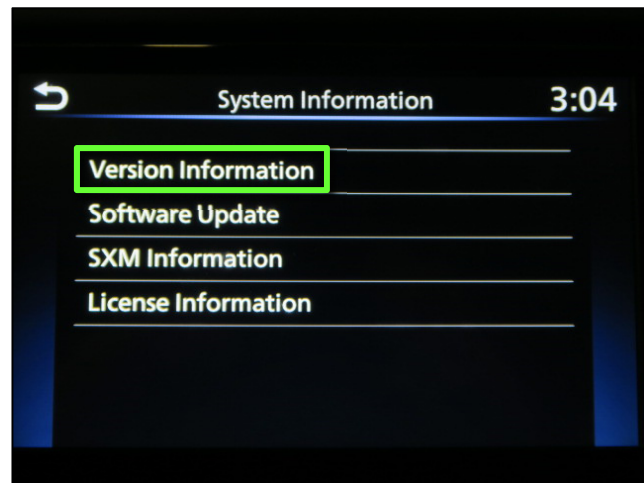
Figure 5

4. Select **Version Information**.

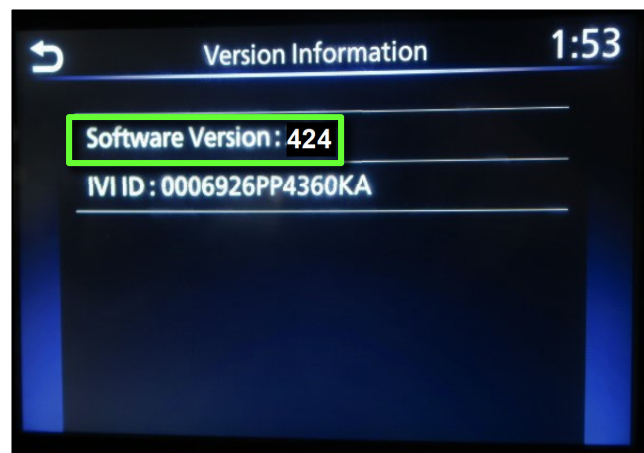
Figure 6

5. Verify the **Software Version** is numerically below 424.
- If the **Software Version** is below 424, proceed to step 6 on page 5.
  - If the **Software Version** is not below 424, the **SERVICE PROCEDURE** is complete. Proceed to **CLAIMS INFORMATION** on the last page of this bulletin.

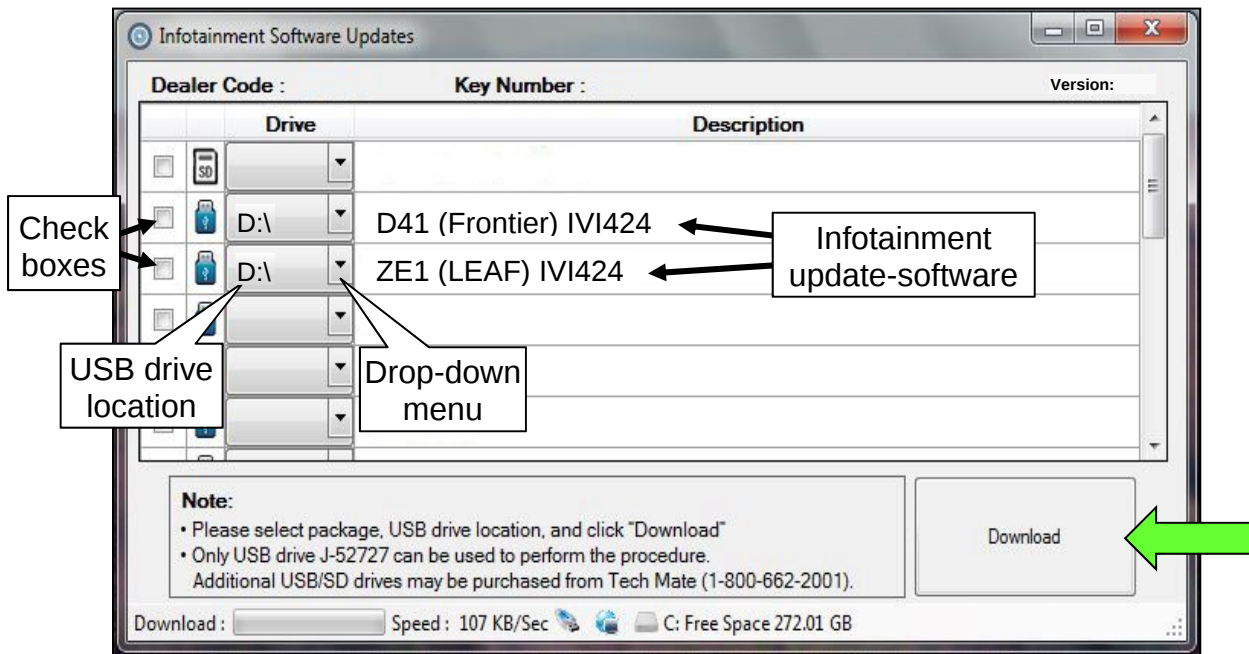
Figure 8

9. Select the check box next to one of the following model specific infotainment update-software descriptions:
  - D41 (Frontier) **IVI424**
  - ZE1 (LEAF) **IVI424**
10. Use the drop-down menu and select the location of the USB drive that was inserted in step 6.

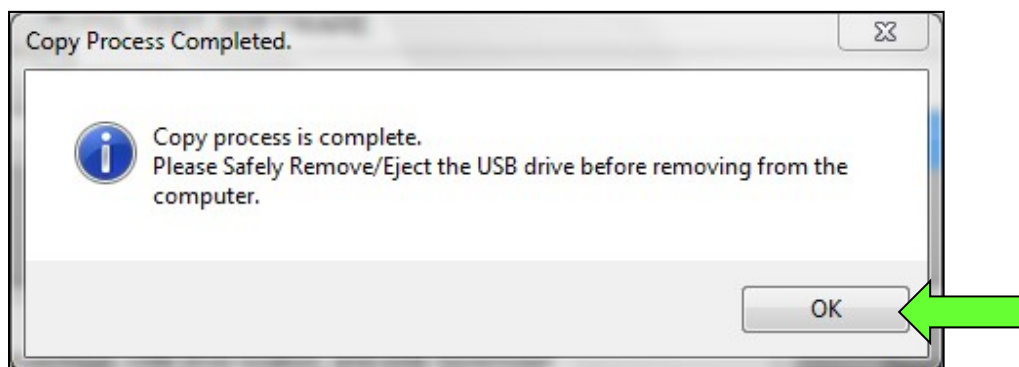
11. Select **Download**, and then wait for the download to complete.  
**HINT:** The update-software is estimated to take 10-15 minutes to download to the USB drive.
12. Select **OK** when the message in Figure 9 is displayed.

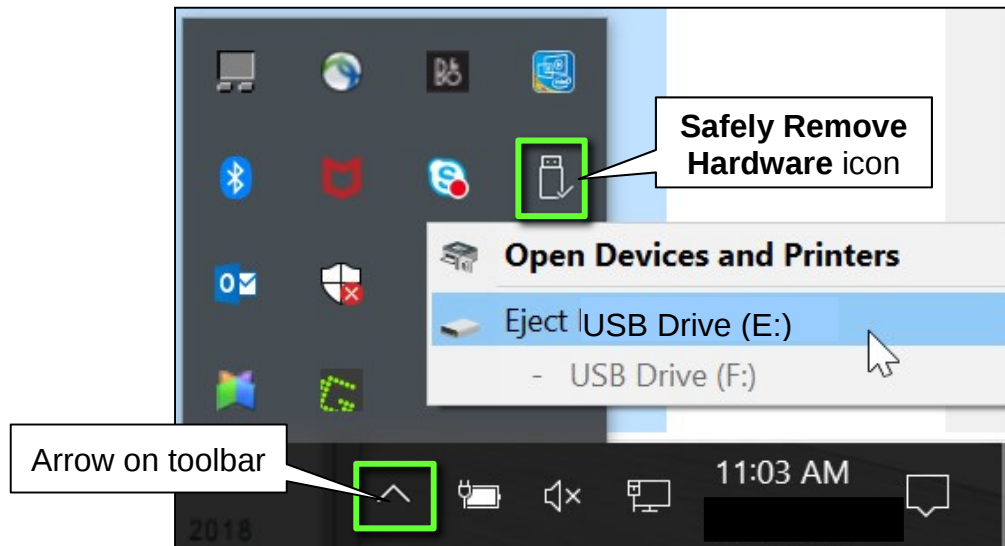
Figure 10

- a. From the PC toolbar, select the **Safely Remove Hardware** icon.
  - o The icon is on the toolbar, or can be found after selecting the arrow.
- b. Select the USB drive to be removed, and then remove the USB drive from the CONSULT PC.

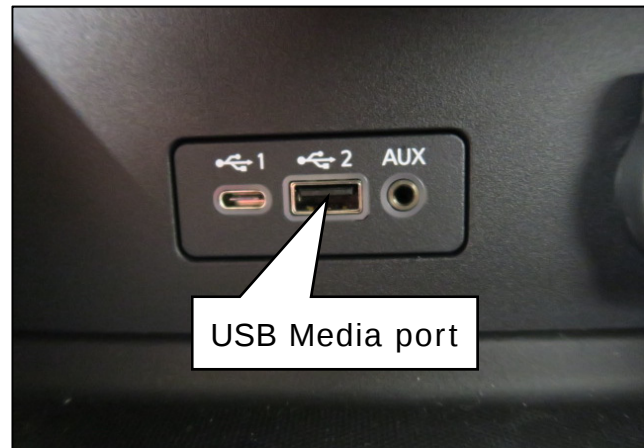
Figure 11

17. Insert the USB drive with the infotainment update-software into the vehicle's USB media port (Figure 11).
  - Do not remove the USB drive during the update to the vehicle until instructed to.

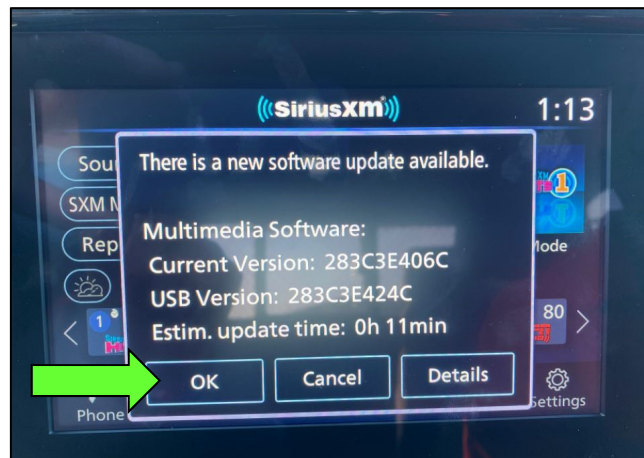
18. Wait approximately 10-30 seconds for the screen in Figure 12 to appear, and then select **OK**.

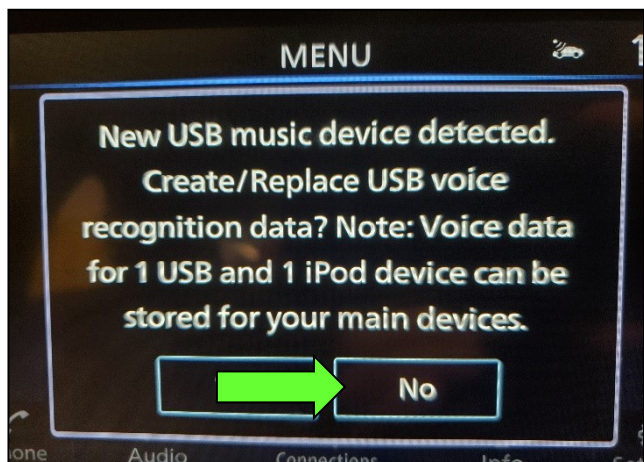
- If the screen in Figure 13 is shown, select **No**.

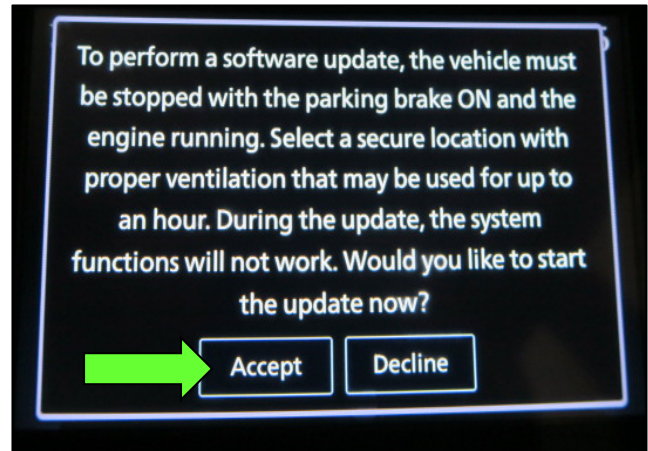
Figure 14

19. Review the software update requirements, shown in Figure 14, and then select **Accept** to start the reprogramming.

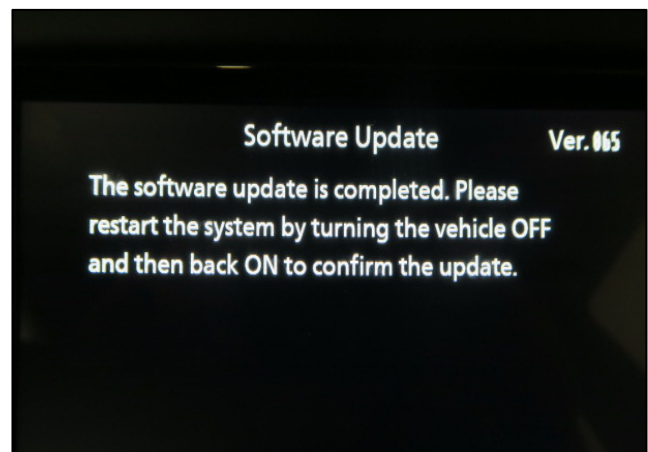
20. When the message shown in Figure 15 is displayed, remove the USB drive from the USB media port.

Do not remove the USB drive until the screen in Figure 15 is displayed. If removed prior to this screen being displayed, the AV control unit may be damaged

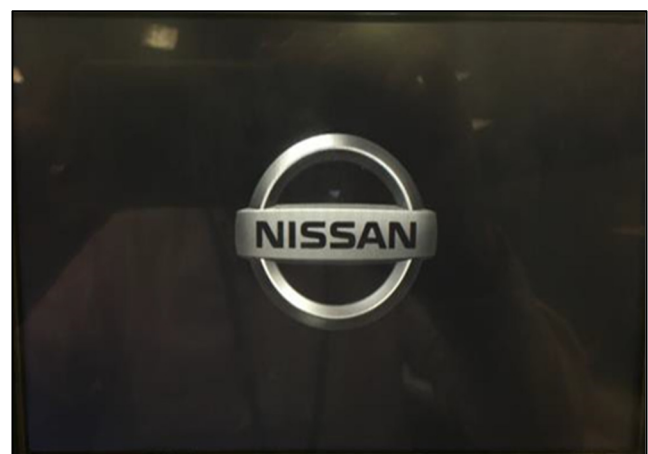
Figure 16

21. Turn the ignition OFF.
22. Open and close the driver door.
23. Restart the engine.
24. Allow the system to boot up completely (approximately 30 seconds).
- The Nissan logo will be displayed during the reboot (Figure 16).

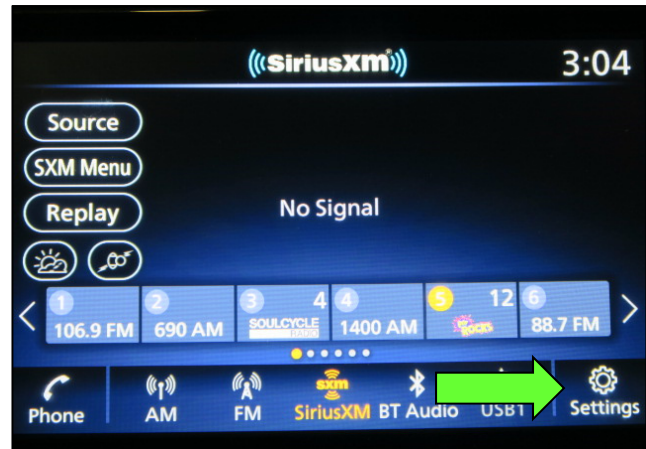
Figure 17

25. Select **Settings**, located in the lower right hand corner of the AV control unit display (Figure 17).

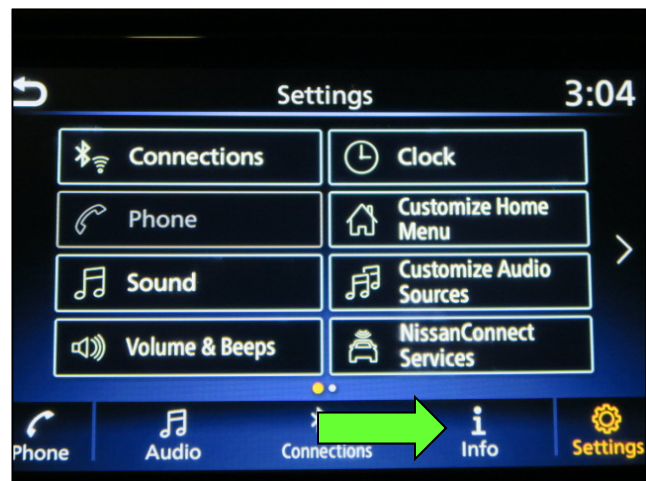
Figure 18

26. Select **Info**.

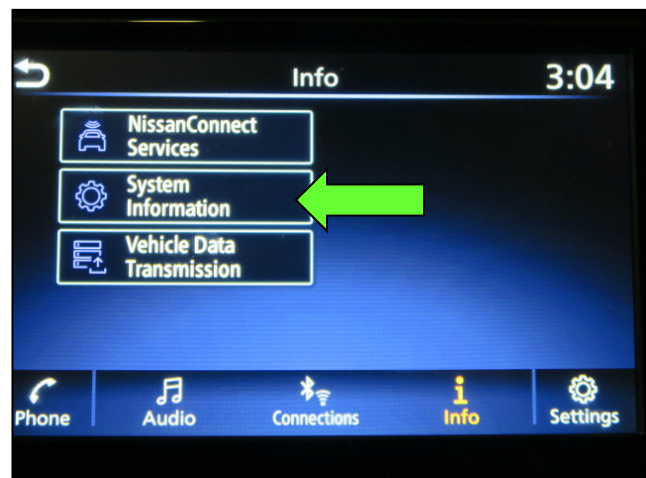
Figure 19

27. Select **System Information**.

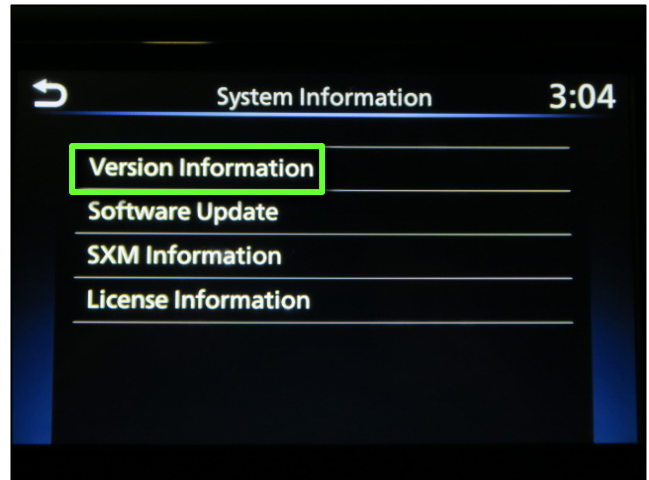
Figure 20

28. Select **Version Information**.

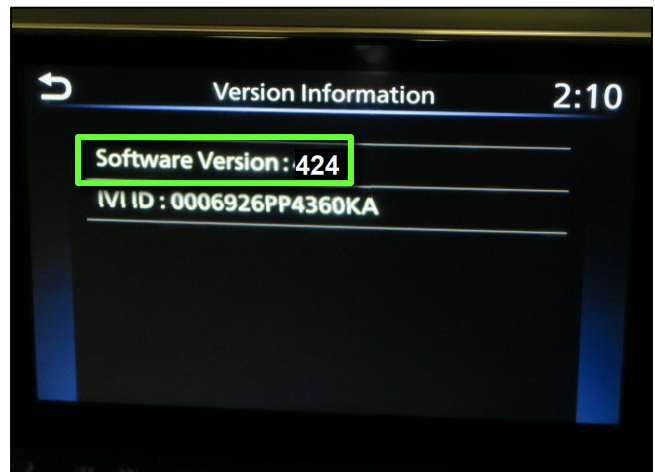
Figure 21

29. Verify the **Software Version** is now **424**.

- If the **Software Version** is NOT **424**, start this procedure over and verify that the correct software shown in step 9 on page 6 is downloaded.
- If the **Software Version** is 424, the reprogramming is complete.
